Methodist and Nonconformist Chapels in Cornwall

Appendix 1

An Illustrated Guide to Historic Cornish Chapels

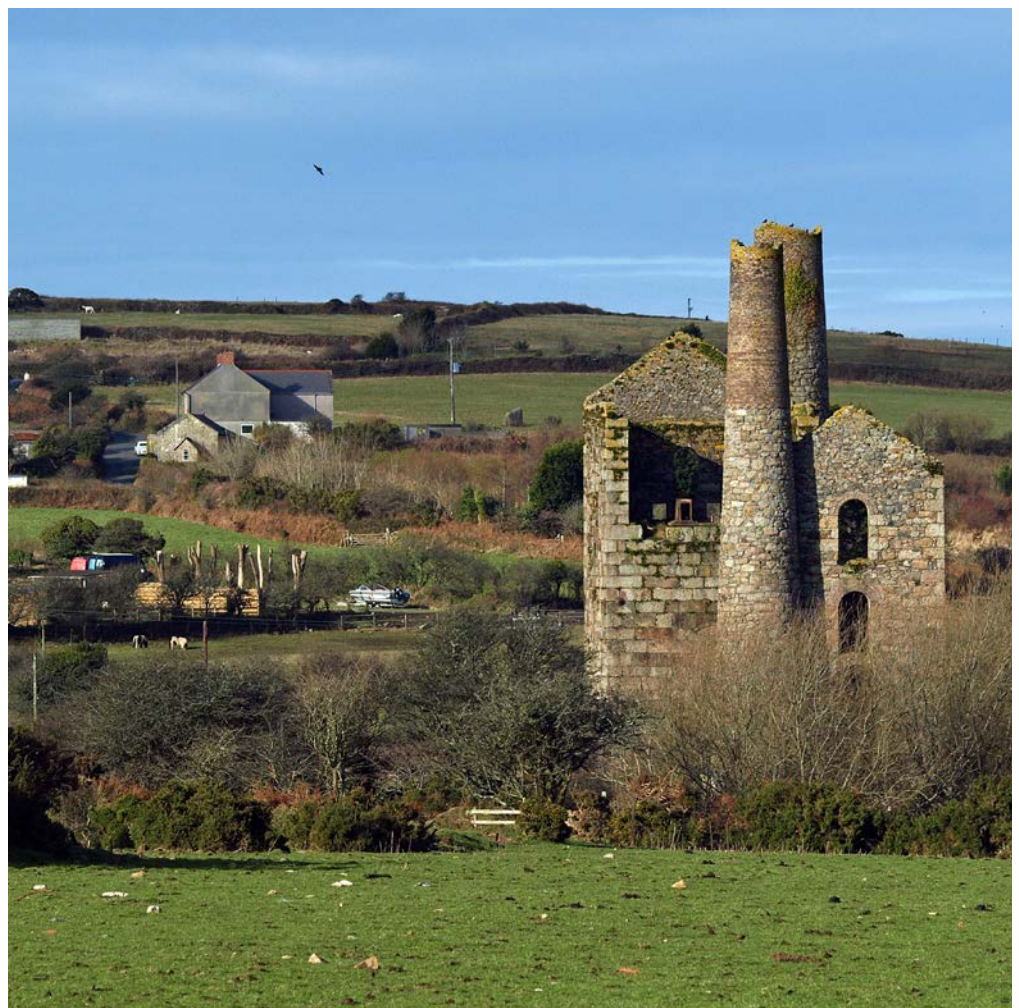
Figure 1:
The former Wesleyan
Chapel (not listed) at Little
Condurrow is sited close
to Wheal Grenville mine
(Grade II). © Eric Berry

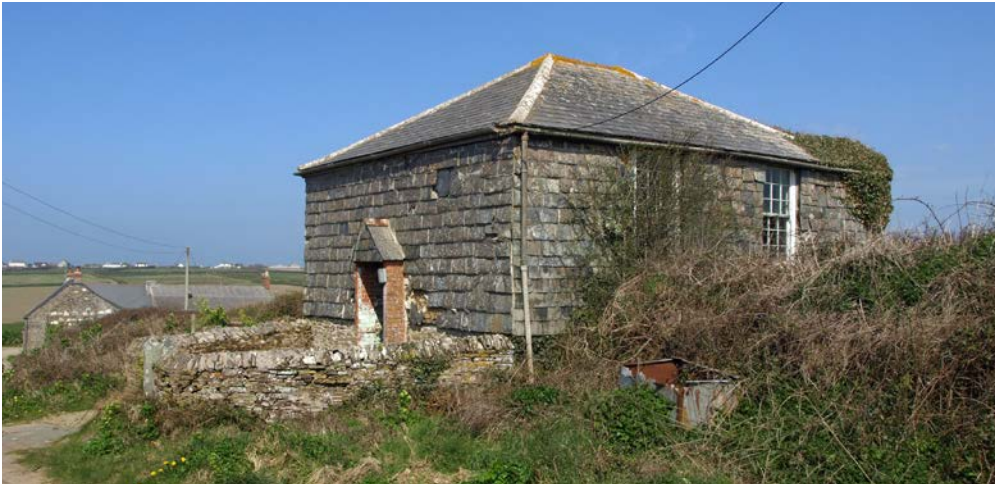
Figure 2:
The small vernacular chapel (Grade II) in the farming hamlet at Tregona near Padstow relates to a farming landscape.
© Eric Berry

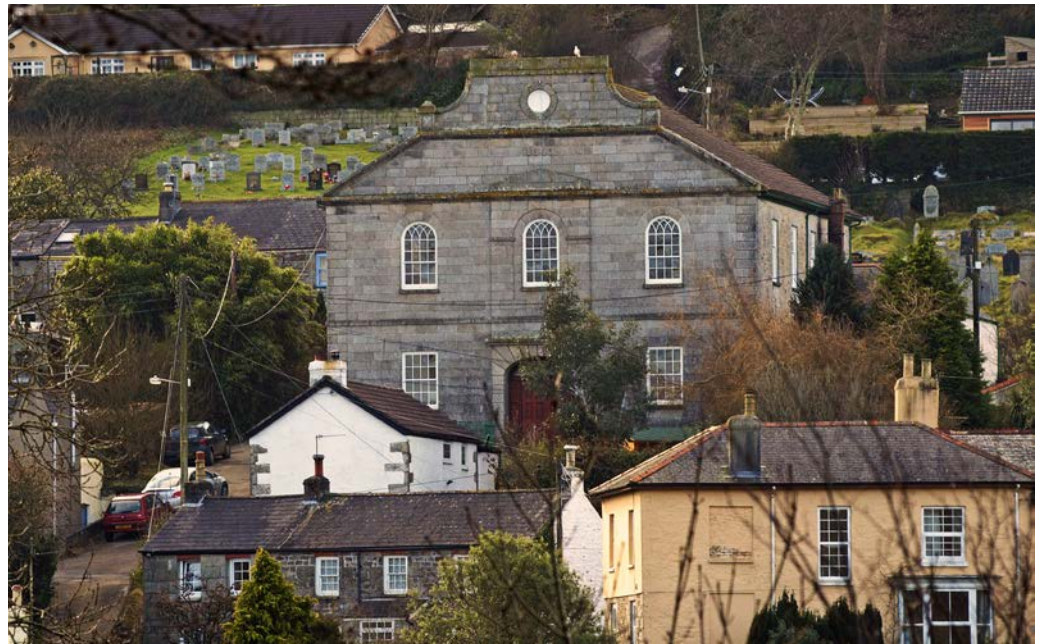
Figure 3:
The large classical Wesleyan chapel of 1843 at Ponsanooth (Grade II*) dominates this former industrial village.
© Eric Berry

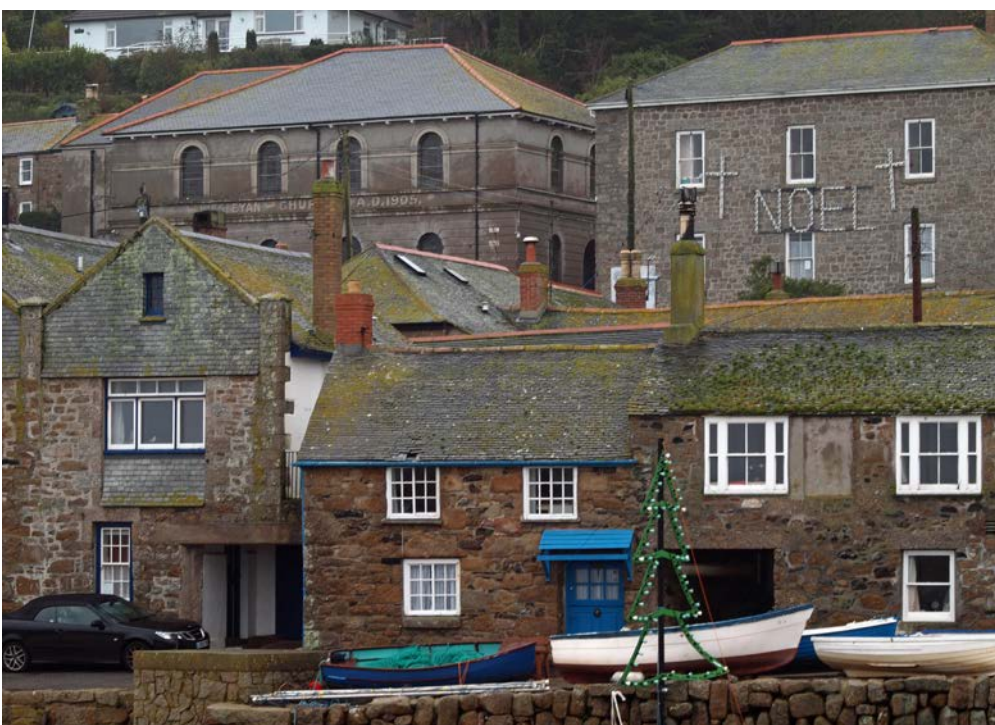
Figure 4:
The chapel in the fishing village of Mousehole (Grade II*) has been through a number of makeovers, principally in 1833 and 1905 when the exterior was stuccoed. The later 19th century Sunday School to the right is similarly large in scale.
© Eric Berry

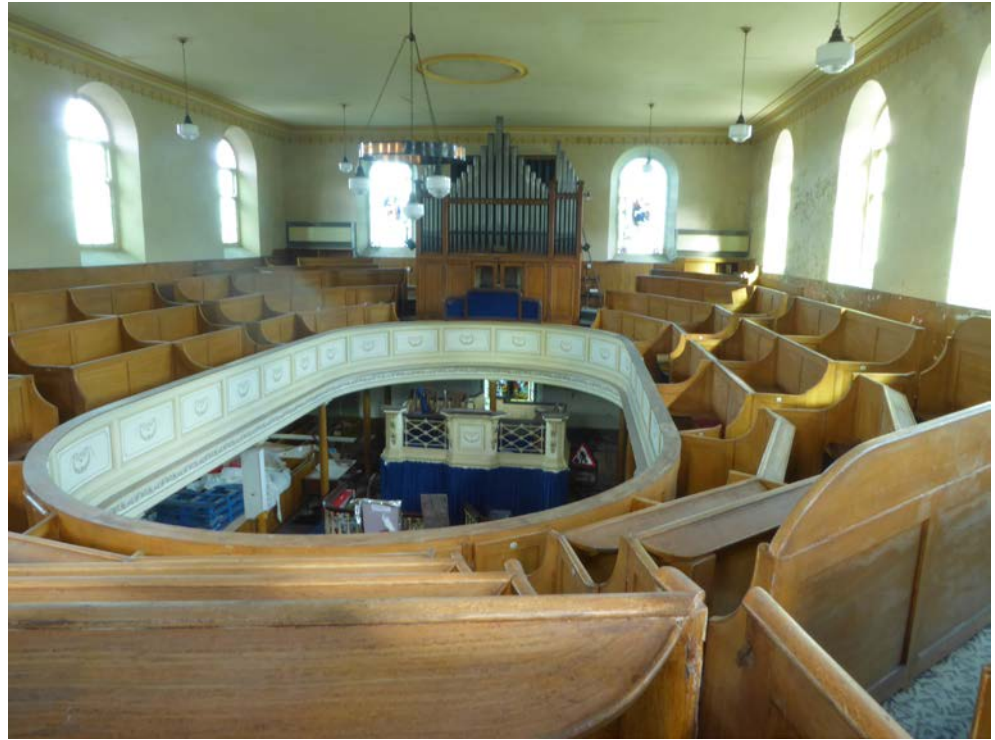
Figure 8:
View from gallery towards
Rostrum, demonstrating
auditory plan form in
Newlyn Trinity Methodist
Chapel (grade II*)

The 'auditory plan', in which the interior of the worship space was designed in order to enable the congregation to hear and see the preacher, was once common to church and chapel. It was largely removed from Anglican churches from the 1840s onwards, replaced by 'medieval' forms with naves, chancels and aisles which emphasised formal processions and the ritual of the sacraments. It is, however, the dominant design for chapels, where aisles were intended to only provide access to the pews and communion area.

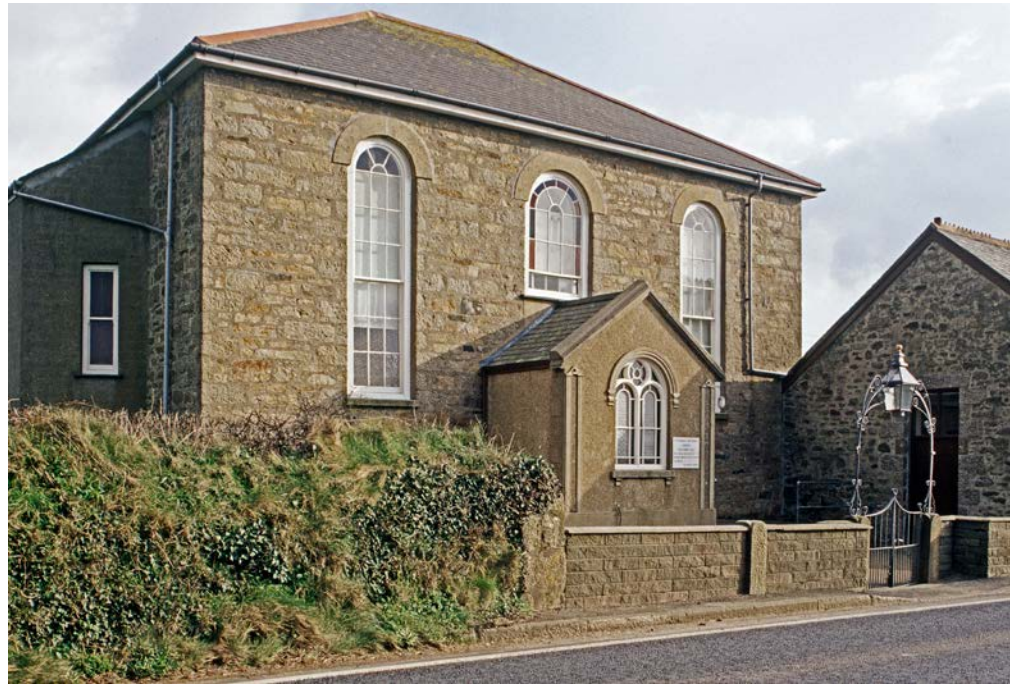
Figure 10:
The rather unusual mid-19th century chapel at Trewennack in Wendron parish has round-arched sash windows set into stone rubble walls. The roadside elevation was fitted with a later central entrance porch so that the later Sunday School (right) was accessed from the roadside forecourt.
© Eric Berry

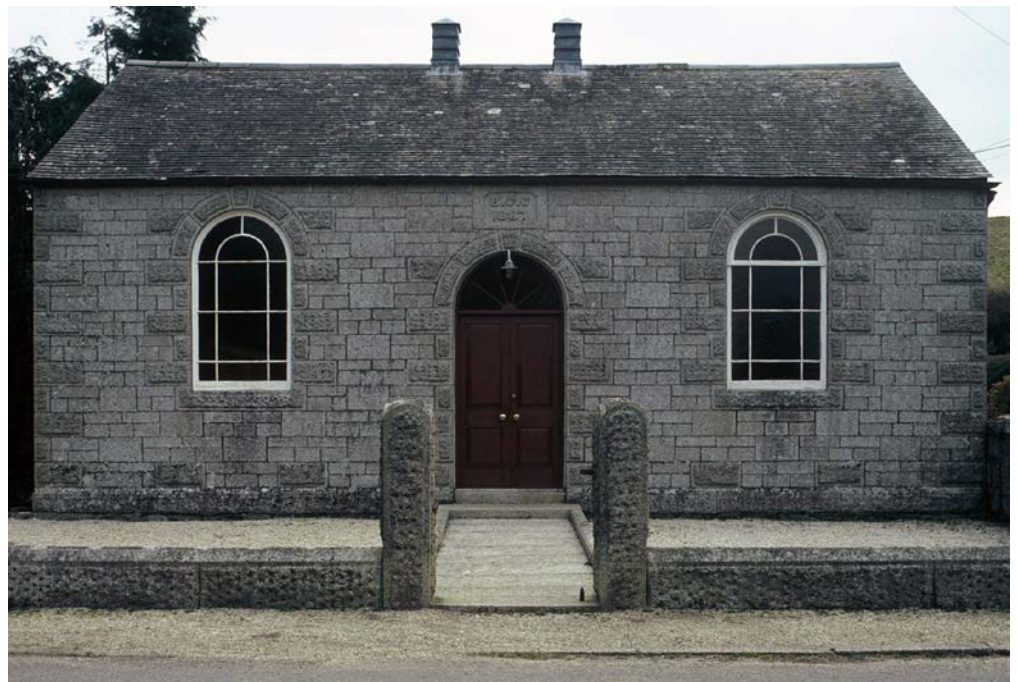
Figure 11:
The side-entry chapel at Lowertown, Wendron (1887) replaces an earlier former chapel (now a ruin). Classical detail – in this case rusticated stonework to the quoins and openings – has been applied to a simple symmetrical elevation.
© Eric Berry

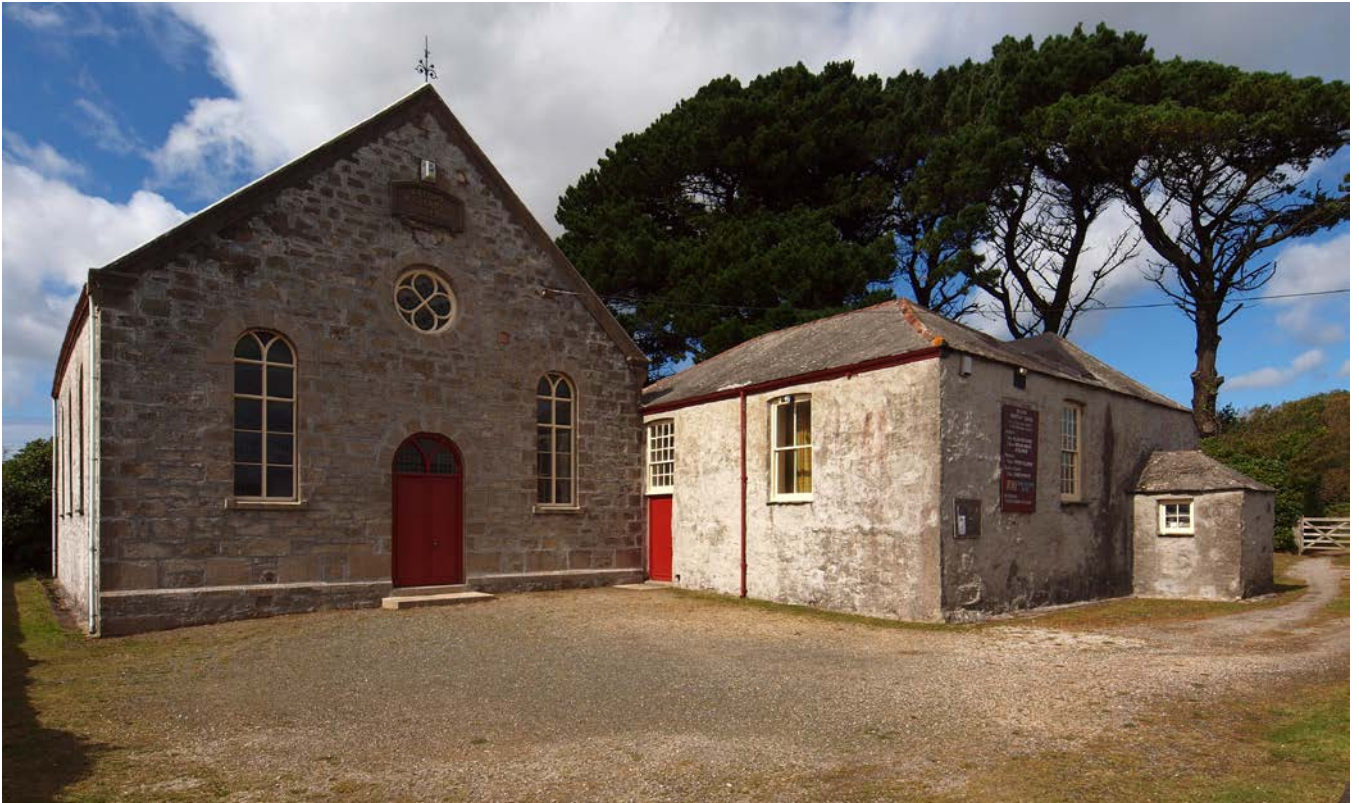
Figure 12:
The gable-entry Wesleyan
chapel at Baldhu (Grade II)
and its adjoining Sunday
School. © Eric Berry

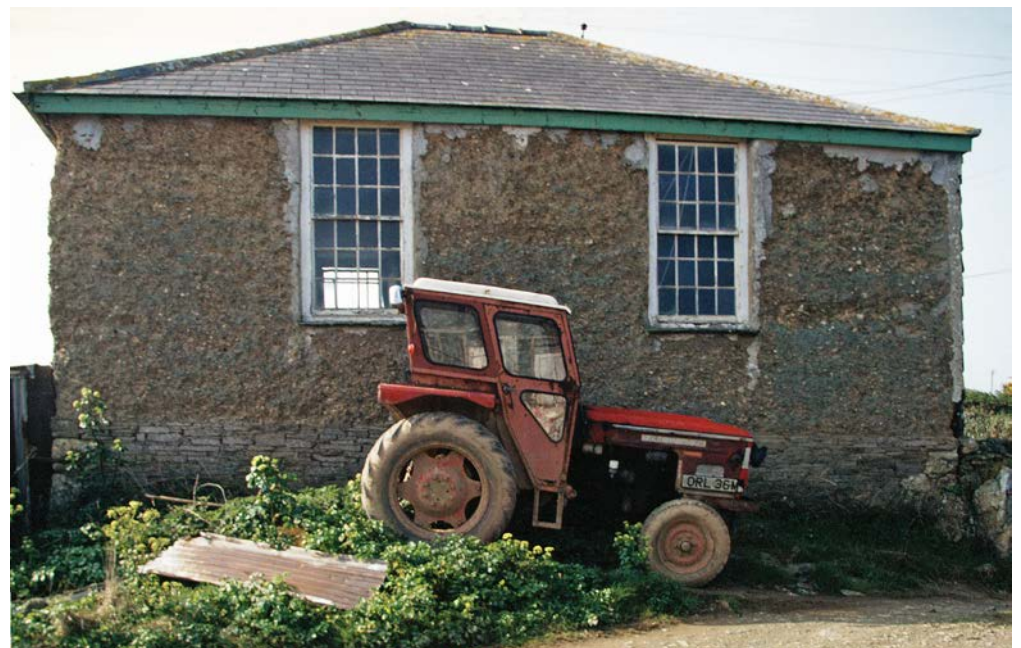
Figure 13:
The 1838 former Free
Methodist chapel at
Tregona (Grade II) in St
Eval parish is a good
vernacular example with
cob (earth) walls on stone
rubble footings.
© Eric Berry

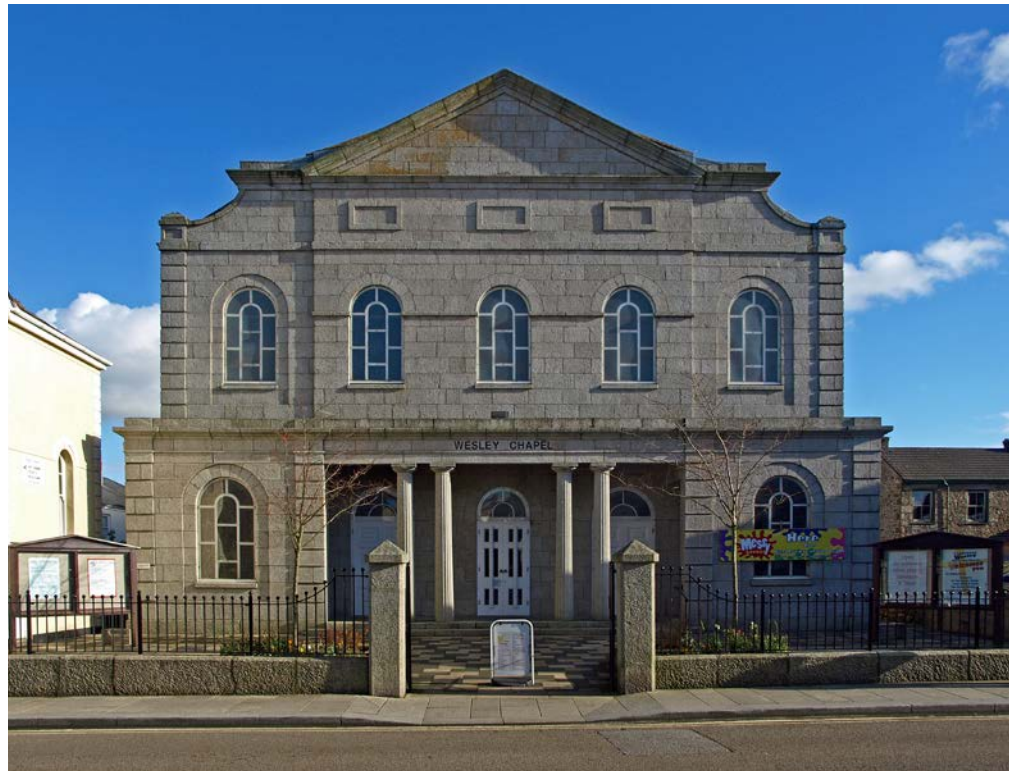
Figure 14:
The 1828 Wesleyan chapel in Camborne (Grade II) is a good example of the larger 5-bay classical chapels that had been built in the most fashionable areas of Cornwall's established county towns (Bodmin, St Austell, Truro, Penzance) as well as its new mining settlements and landscapes. © Eric Berry

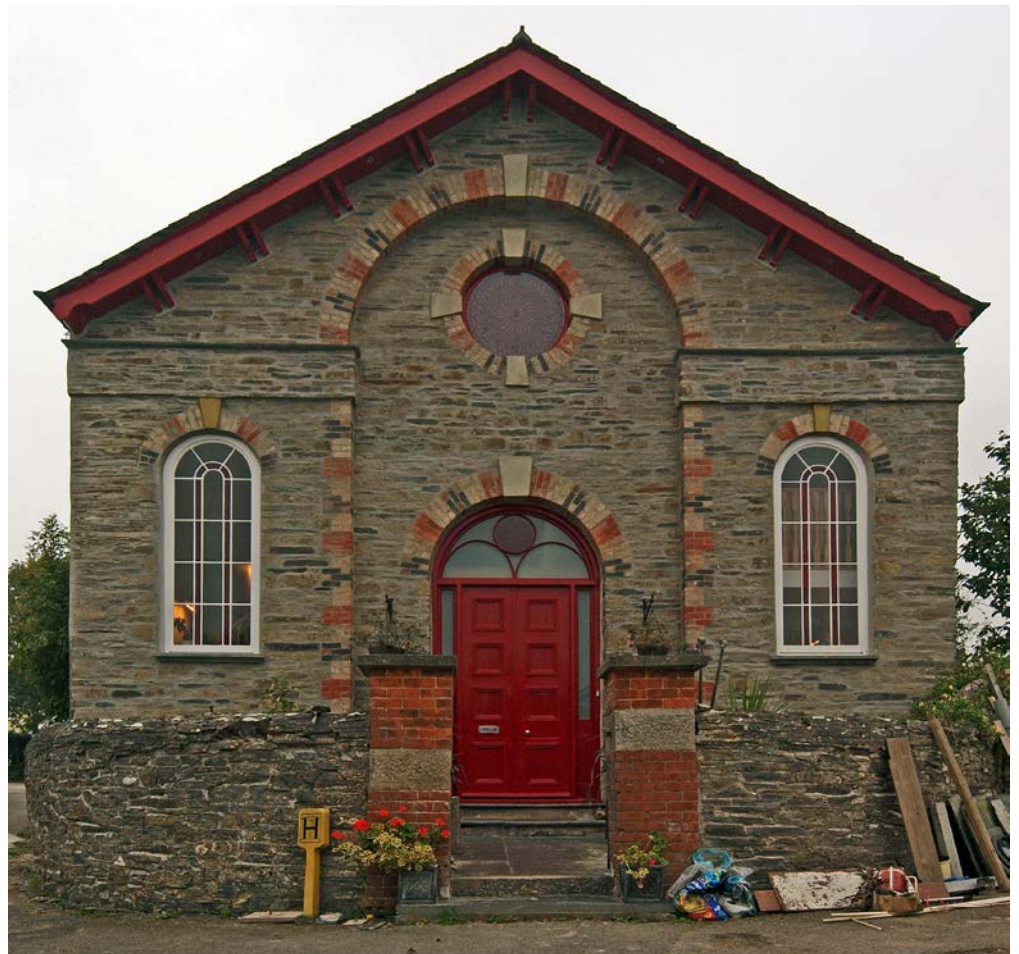
Figure 15:
The gabled façade to this chapel (opened 1874) at Tredrizzick has a recessed central bay rising to an open pediment. Its show front, with the central bay and entrance picked out in coloured brickwork, is almost identical to that of the 1869 chapel at St Tudy (Grade II). © Eric Berry

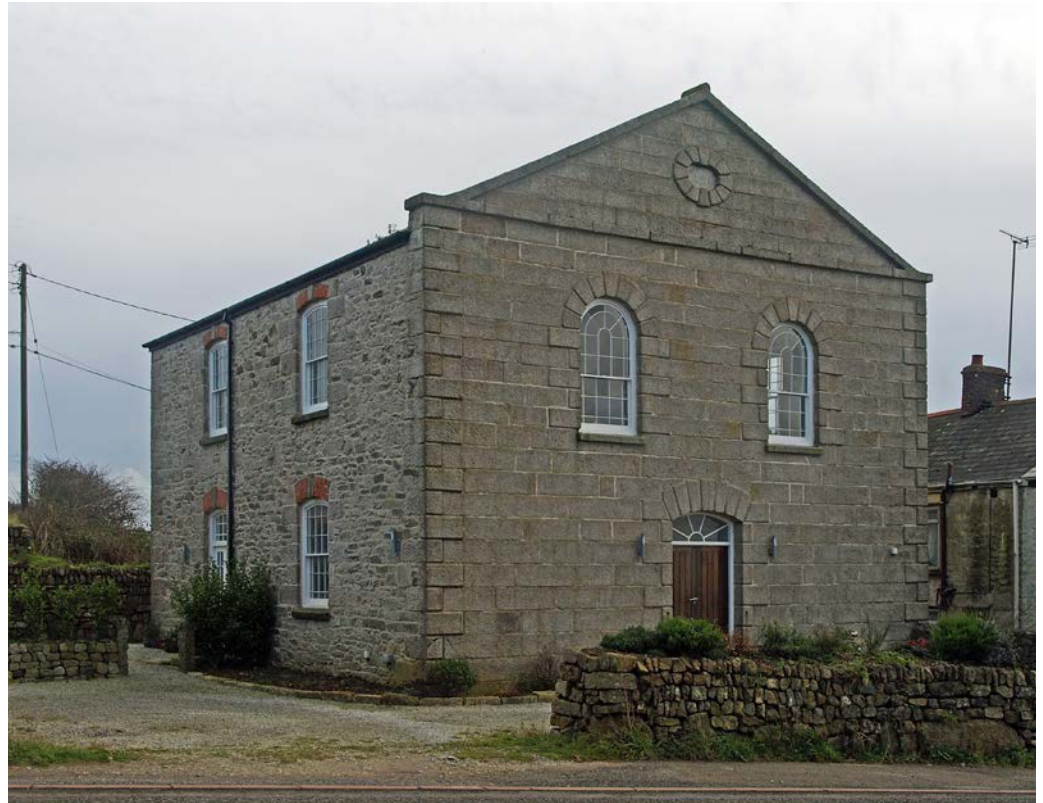
Figure 16:
The former Wesleyan chapel at Manhay (Grade II) in Wendron parish has a fine pedimented ashlar façade, with rusticated surrounds to the door and sash windows lighting the gallery. The building has now been converted to a house but retains its external character.
© Eric Berry

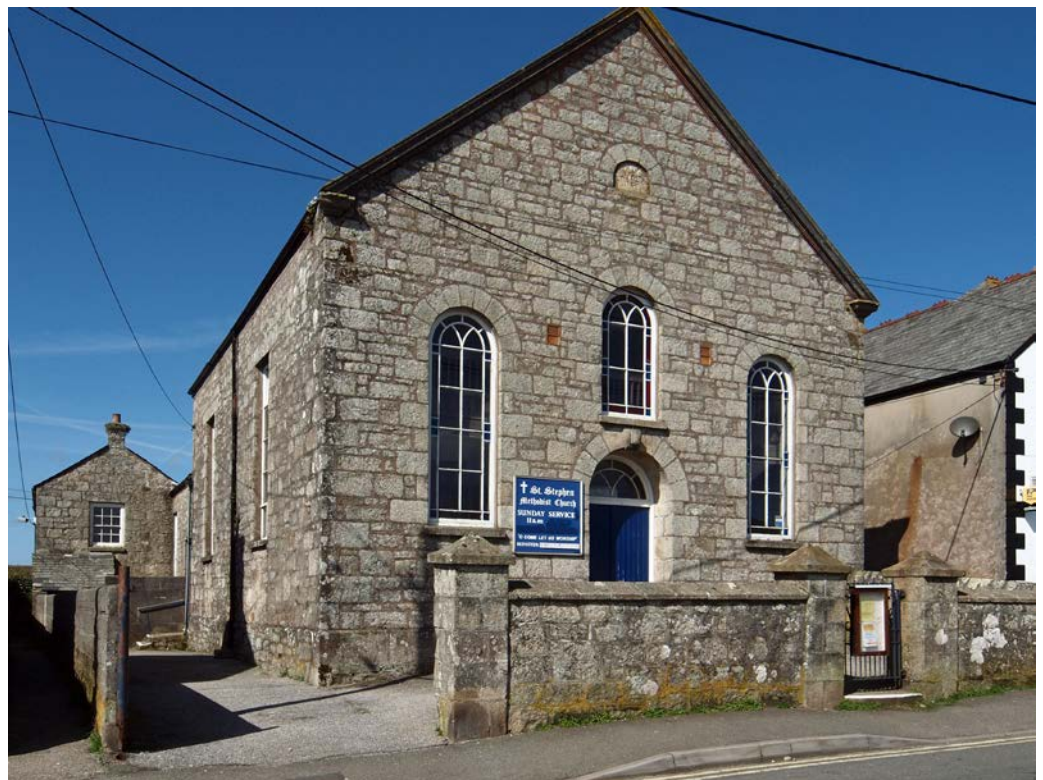
Figure 17:
The Wesleyan chapel at St Stephen in Brannel (1870, Grade II), is one of a group of similarly-designed chapels, built into the 1870s, in this china clay district west of St Austell.
© Eric Berry

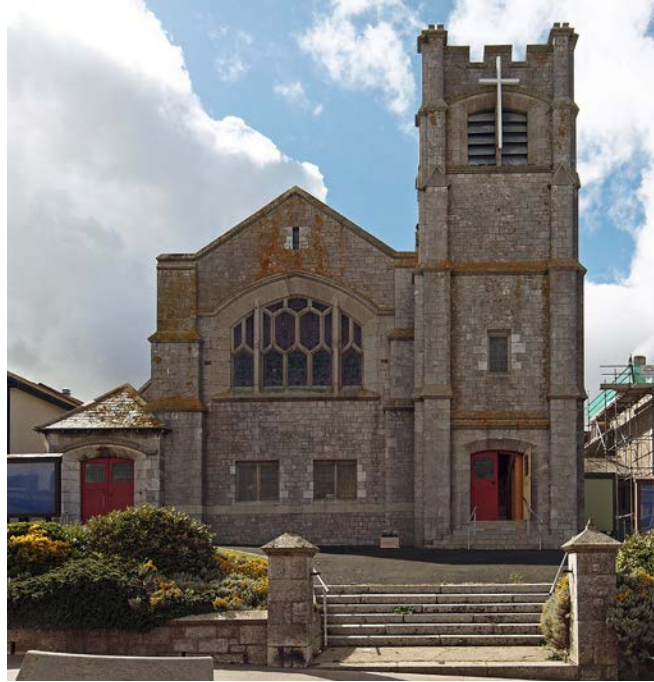
Figure 18:
The 1904 East Street Wesleyan chapel in Newquay (Grade II), by the architects Bell, Withers and Meredith, is a good example of the free Gothic style that had become fashionable by then.
© Eric Berry

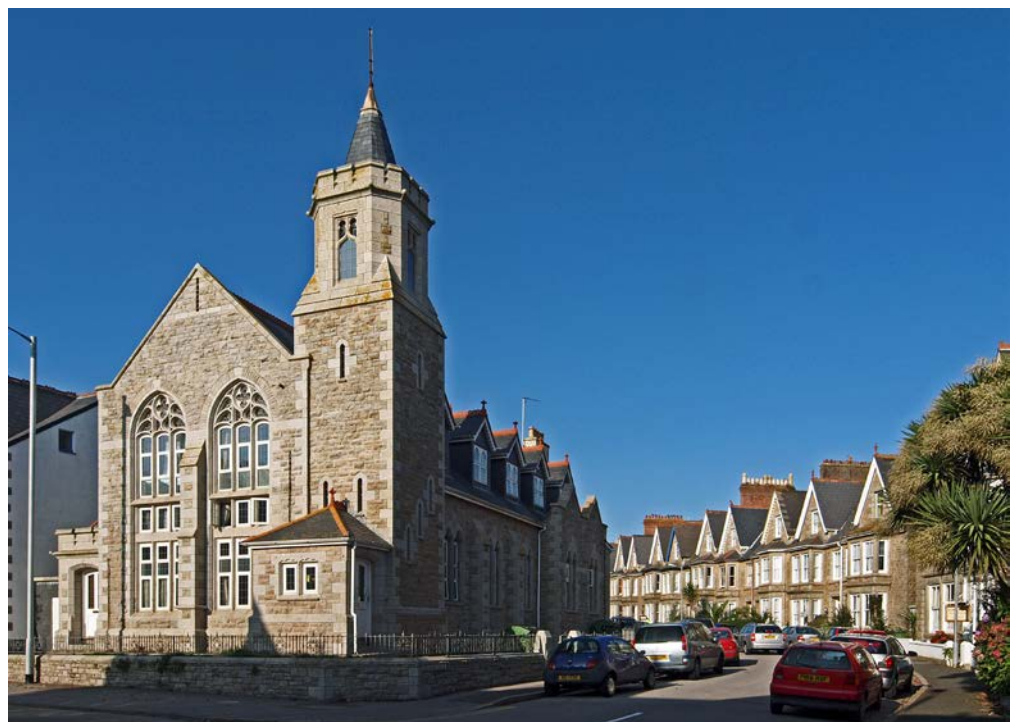
Figure 19:
The Gothic-style 1903 Alexandra Road chapel in Penzance (now converted to residential flats), by James Firth of Oldham, relates well to housing of the same period.
© Eric Berry

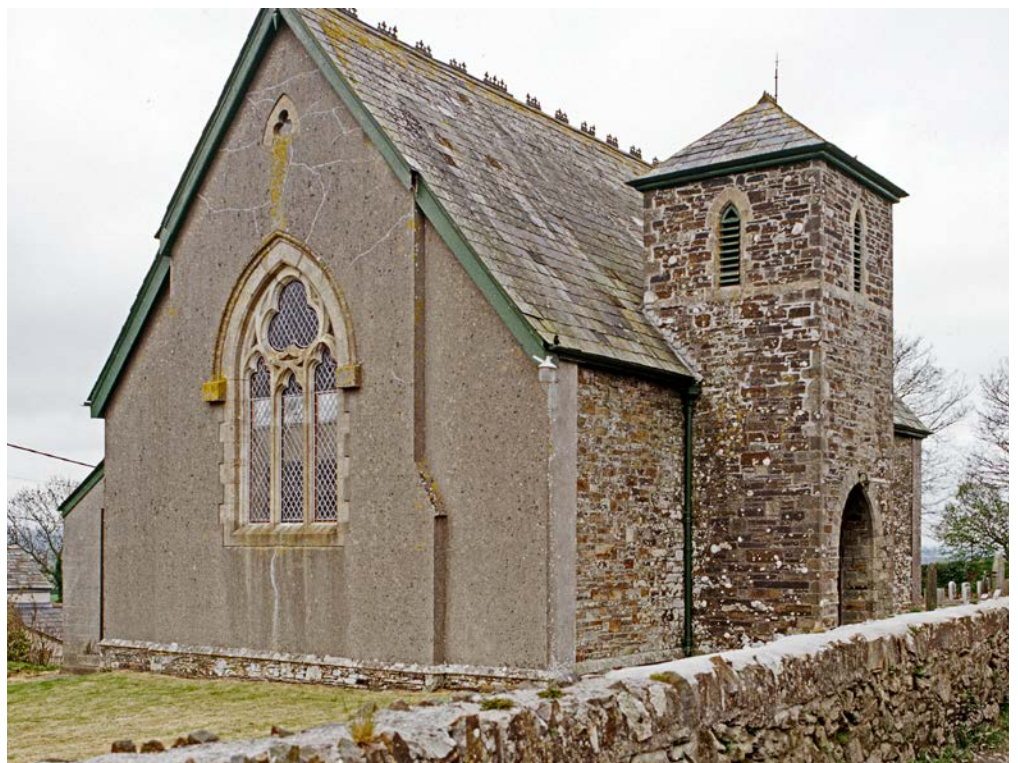
Figure 21:
The 1873 chapel of St Thomas the Apostle at Tregadillet is one of a small number of Methodist chapels in Cornwall with a bell tower.
© Eric Berry

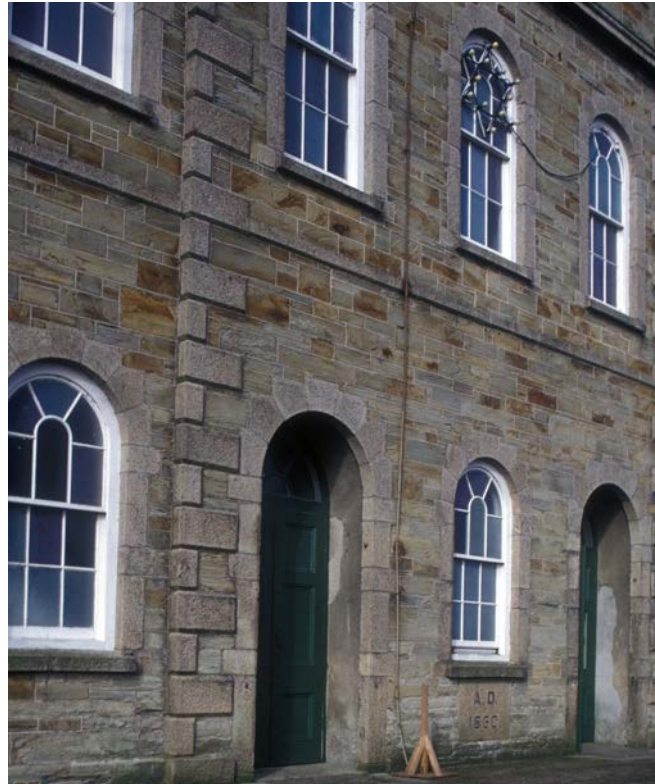
Figure 22:
Panelled doors with
fanlights and hornless
sash windows, as
exemplified within the
1860 pedimented façade of
the Wesleyan chapel at St
Agnes (Grade II).
© Eric Berry

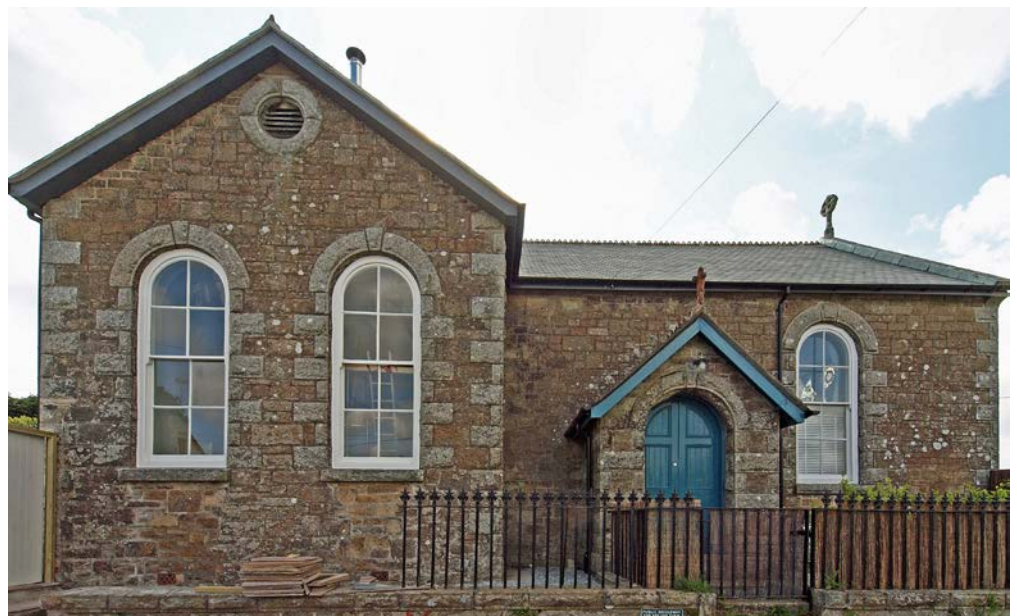
Figure 23:
Horned sash windows are
marked by projecting lugs,
which help to strengthen
the meeting rails in
combination with the
heavier glass used from
the mid-19th century. They
are a type commonly used
from the 1870s in Cornwall.
This is the (unlisted) late
chapel at Newbridge in
Sancreed parish.
© Eric Berry

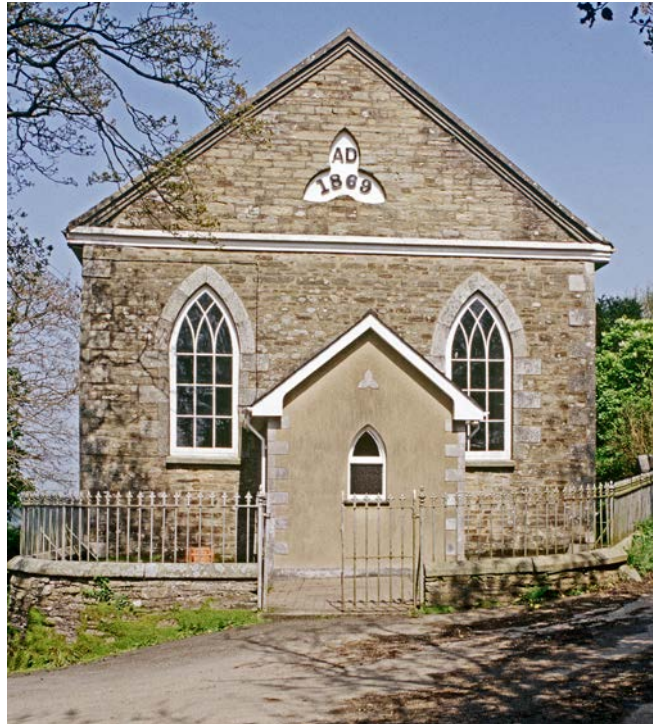
Figure 24:
The windows of the 1869 chapel at Porthkea (Grade II) are distinctive examples in the 18th century Picturesque Gothic style, with intersecting glazing bars. © Eric Berry

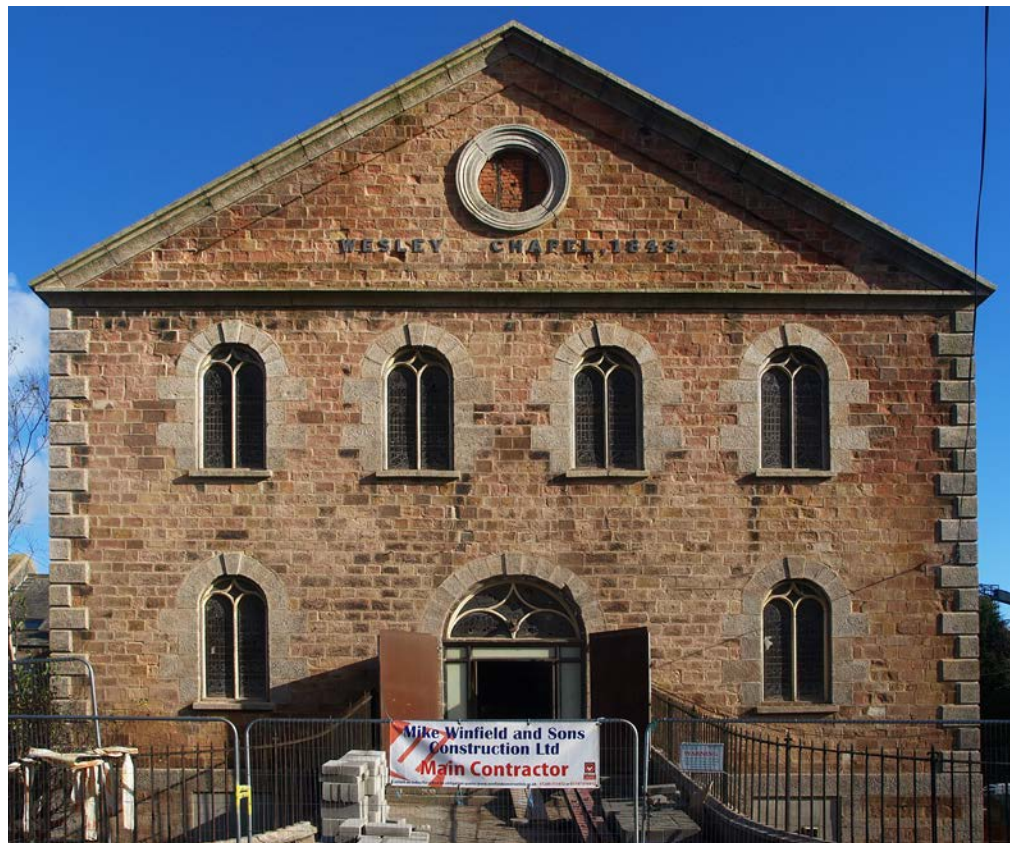
Figure 25:
By the end of the 19th century windows were being installed with paired lights and a roundel, either in a pointed-arched or round-headed opening. These windows were inserted within the original openings of the 1843 (Grade II) Classical chapel at Tuckingmill.
© Eric Berry

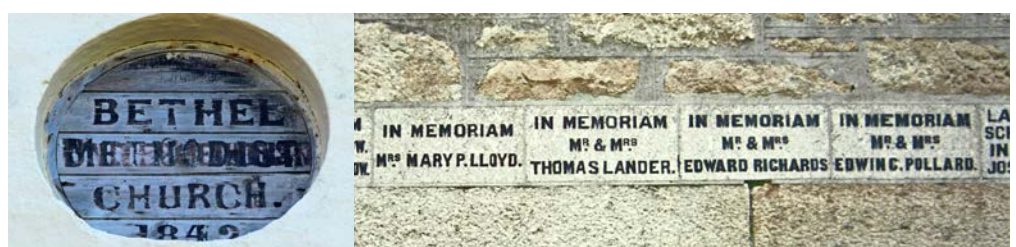
Figure 26:
Datestones were often resited and testify to the foundation of a chapel society rather than the date of the building. The resiting of these stones in later fabric also testifies to the reverence in which past chapel society members and benefactors were held and the importance of demonstrating a congregation's antiquity and place in its community.
© Eric Berry

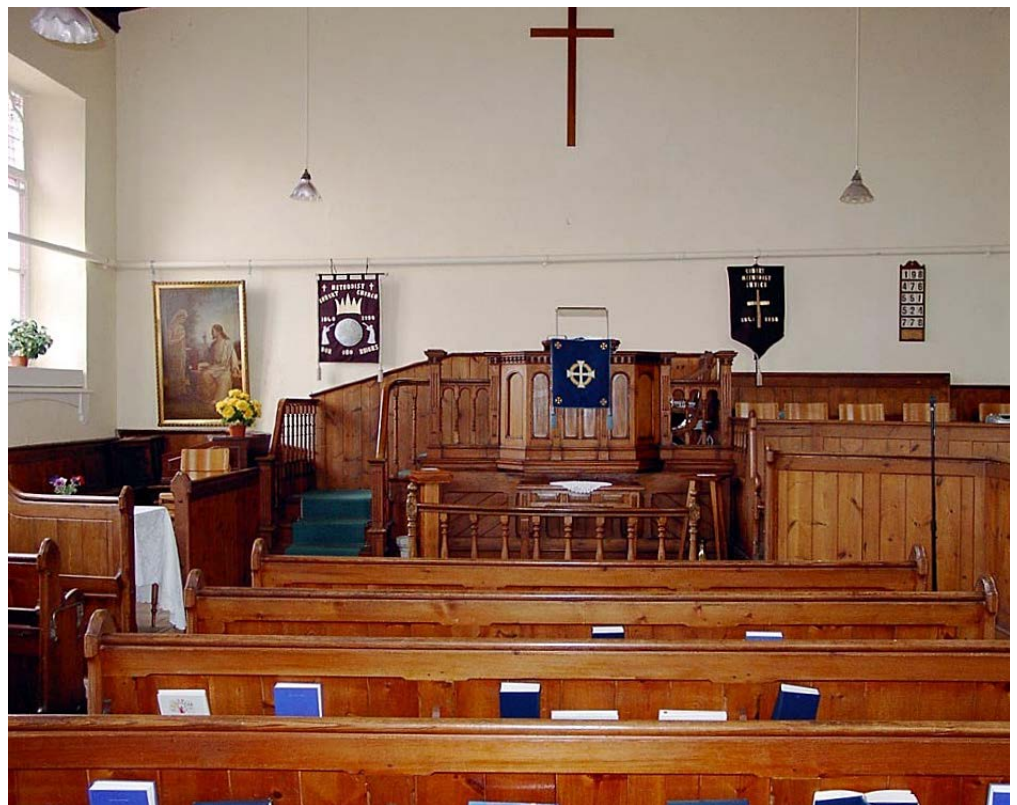
Figure 27:
The former 1849 Wesleyan chapel at Cubert (Grade II), now closed, was refitted in the late-19th century. The pews and rostrum were of varnished pitch-pine, which is characteristic of this period. The layout of the pews either side of the rostrum possibly repeats the original pew arrangement and includes a choir or musicians’ area, or possible former leaders’ pews. © Eric Berry

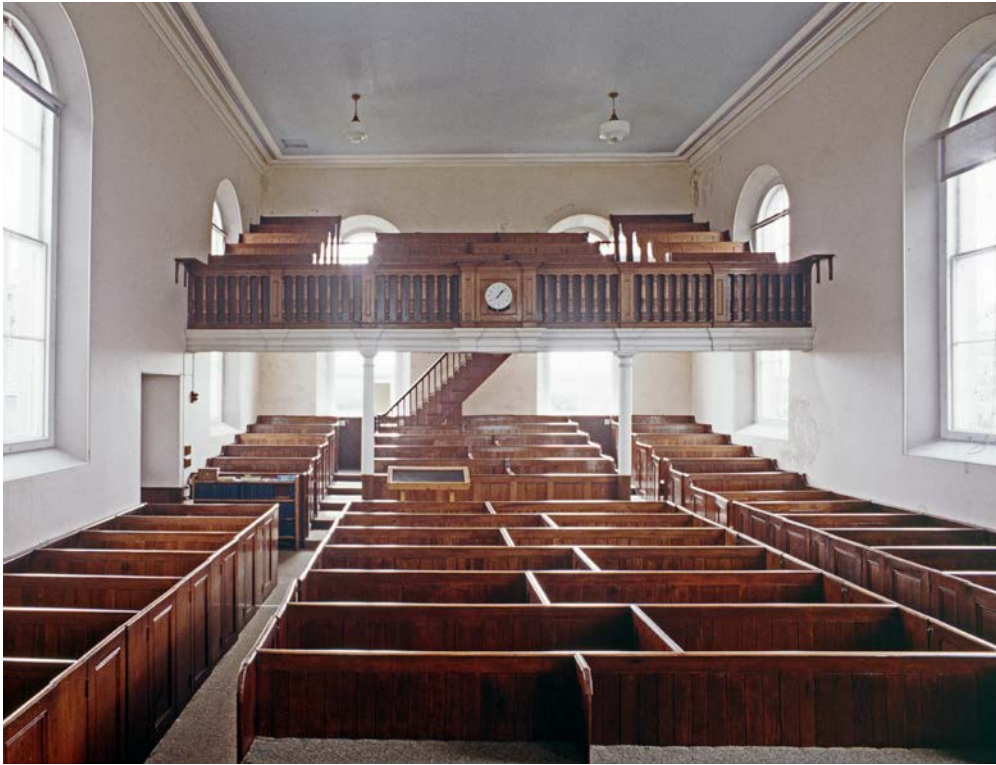
Figure 28:
View towards the end gallery (inserted c.1881) of the former c.1868 Wesleyan chapel at Little Trethewey (Grade II*), St Levan, showing the cast-iron columns on which it is supported and the balustraded front. The rare box pews are ramped up at the rear to enable a view of the rostrum. The rostrum end of the chapel was refitted when the chapel was extended in 1895 at Tuckingmill.

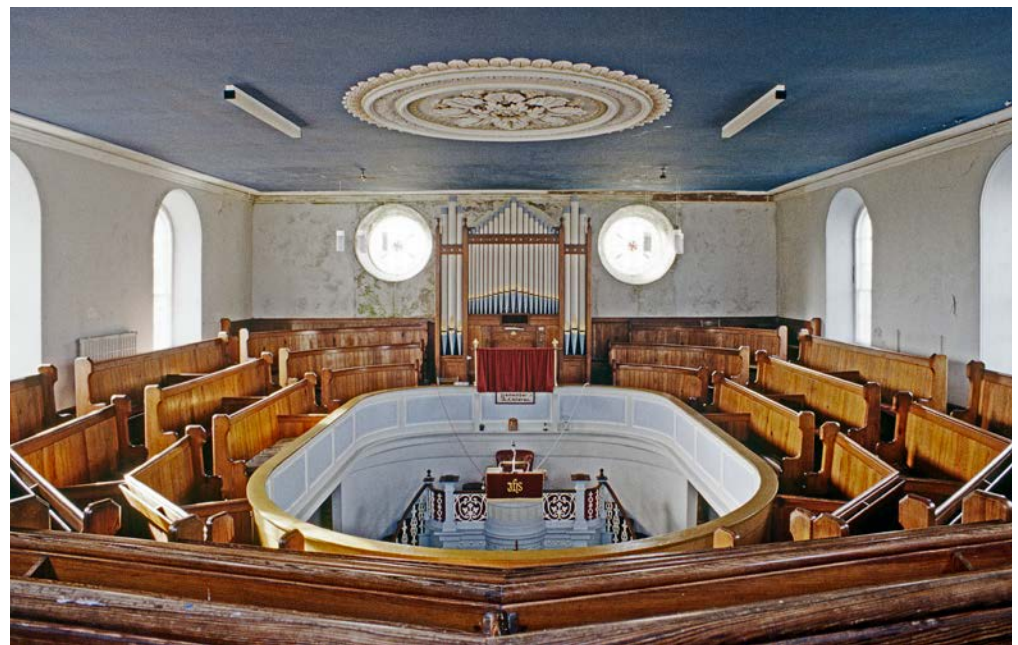
Figure 29:
The interior of the 1862 Wesleyan chapel at Leedstown in Crowan parish (Grade II) has an original gallery. However, as with so many Methodist chapels, the building was re-seated in the late-19th century with simple pitch pine pews. Attention is still focused on the fine original ceiling rose and also drawn to the late 19th century rostrum that may incorporate the bow front of the original pulpit.

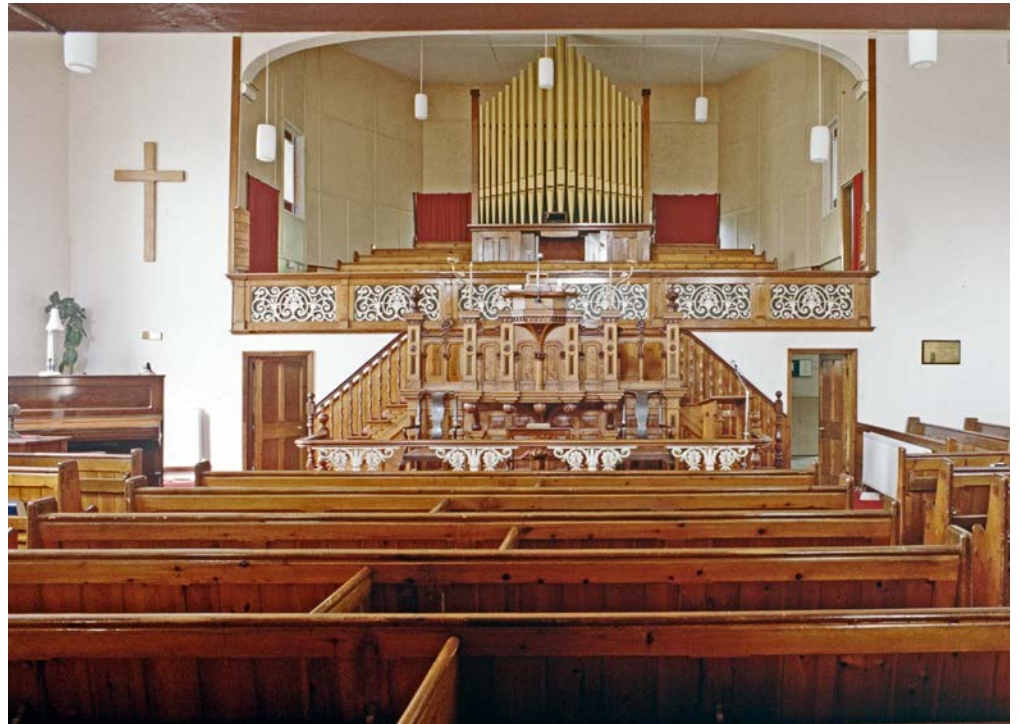
Figure 30:
The 1825 Wesleyan chapel at Carnon Downs in Feock parish has an unusually complex late 19th century rostrum that combines a variety of hardwoods of the original pulpit.
© Eric Berry

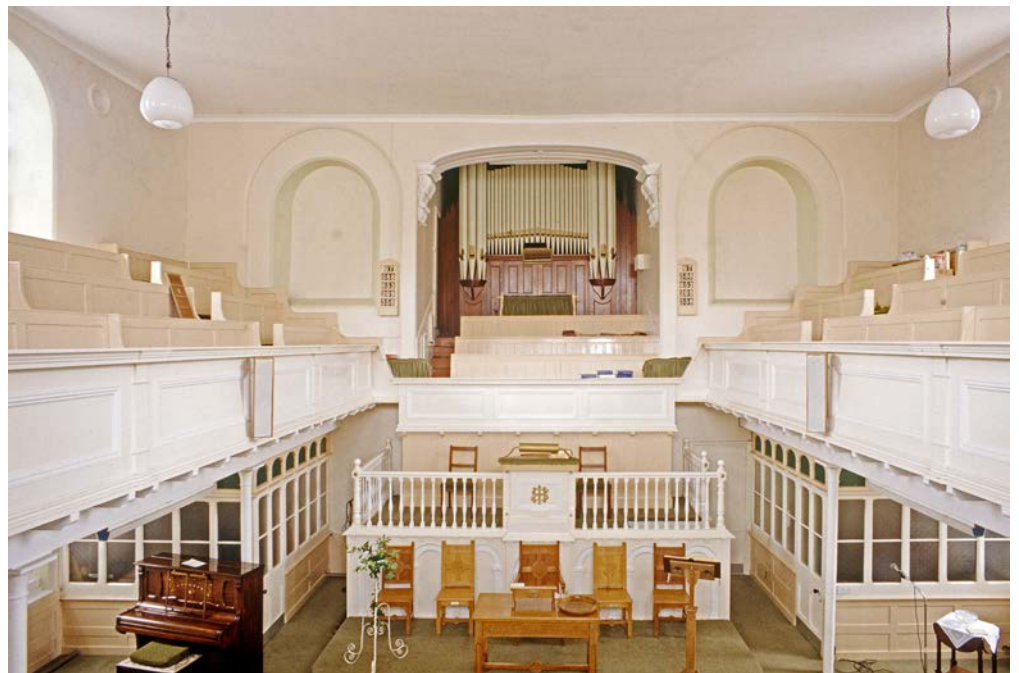
Figure 31:
The galleried United Reform (originally Bible Christian) chapel at Berkeley Vale, Falmouth (Grade II*) has a fine interior with original box pews and large balustraded rostrum. Leaders' pew areas to either side of the rostrum have been screened off at a later date. © Eric Berry

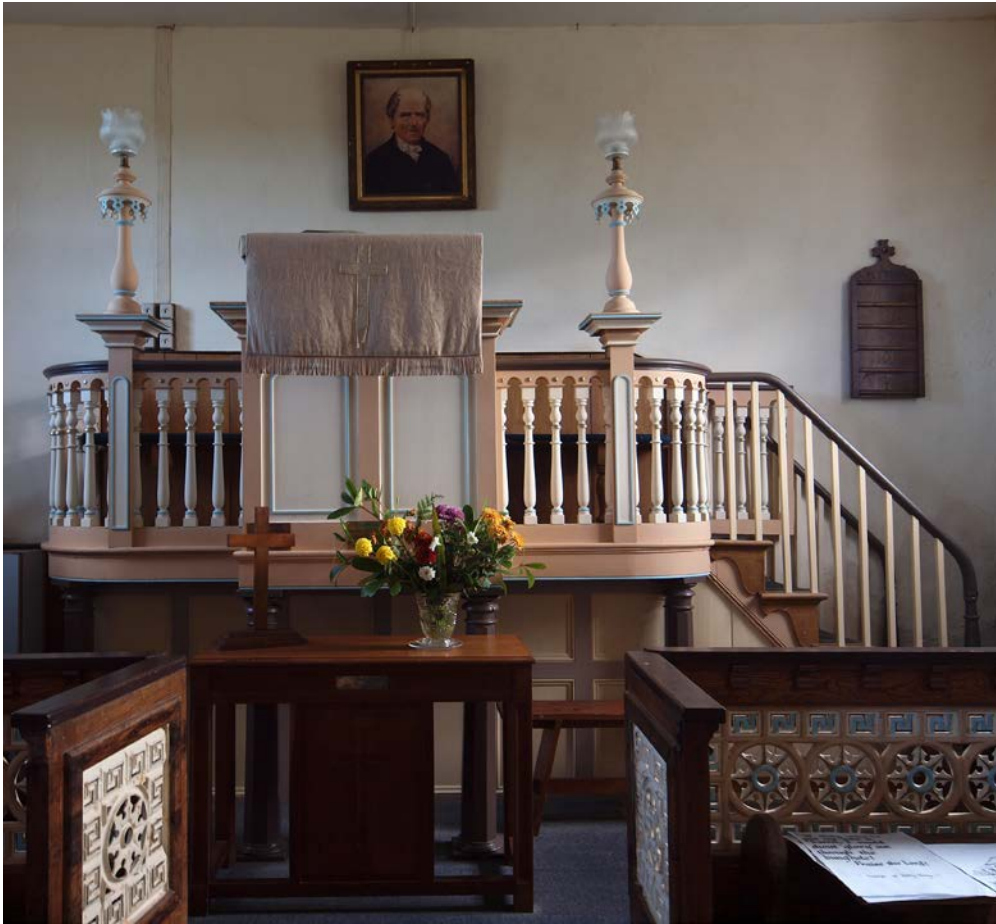
Figure 32:
The fine balustraded
rostrum at Three Eyes,
Kerley Downs (Grade
II) with a portrait of the
charismatic preacher Billy
Bray on the wall.
© Eric Berry

Rostrums are a significant focal point of chapel interiors that date from the 1850s. They have raised platforms for seating several speakers. Some incorporate sections of the earlier pulpits that they replaced. They have railed or panelled timber frontals. Communion rails to the front of rostrums may retain holes for individual communion cups; this generally dates them from after 1900.

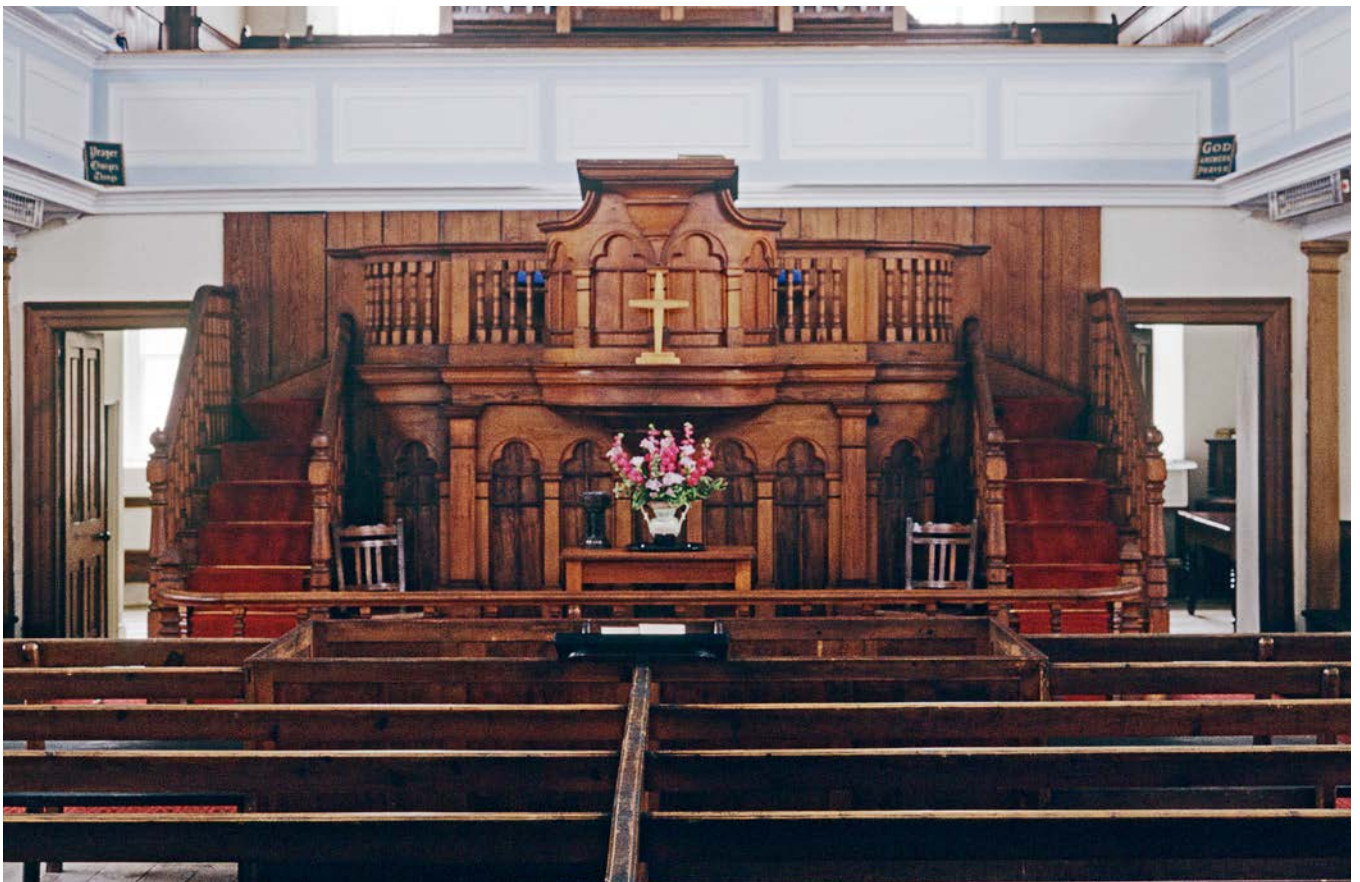
Figure 33:
The former Wesleyan
chapel of 1867 at
Voguebeloth in Illogan
(Grade II*) has its original
internal fittings including
box pews. Benches at
either side of the pews
are a rare survival of free
seating. © Eric Berry

- Certain **combinations of pew types** can be rare. For example box pews paid for by fee paying subscribers flanked by loose “free” benches for those who cannot afford the subscription are extremely rare, with only a few examples remaining.
