Methodist and Nonconformist Chapels in Cornwall

Appendix 1

An Illustrated Guide to Historic Cornish Chapels

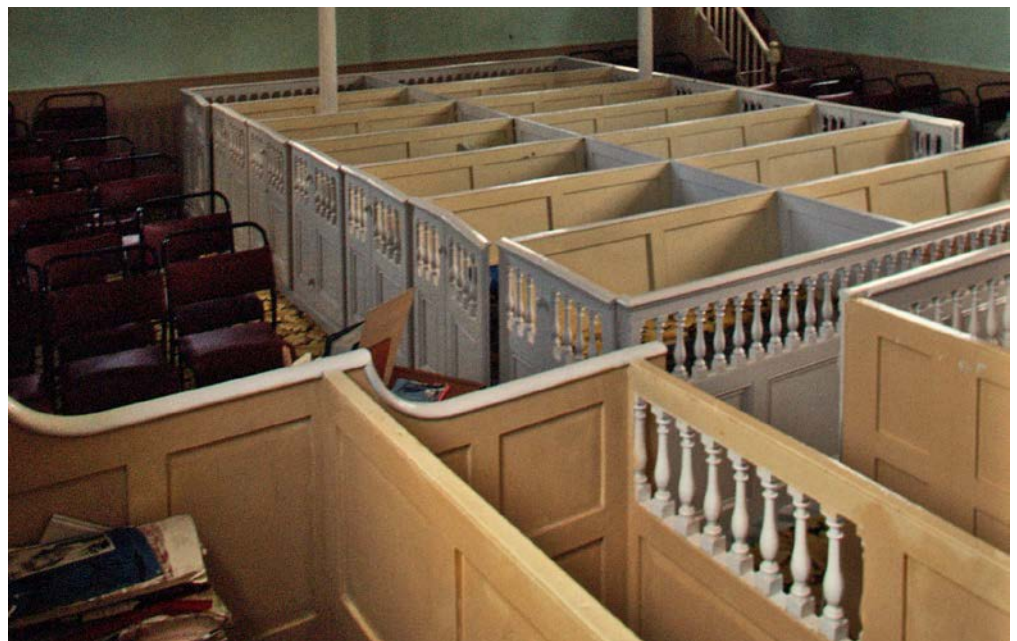
Figure 34:
The 1863 Bible Christian chapel at Wheal Busy (Grade II*) has one of the most complete and interesting interiors in Cornwall, with box pews flanked by areas for free seating. © Eric Berry

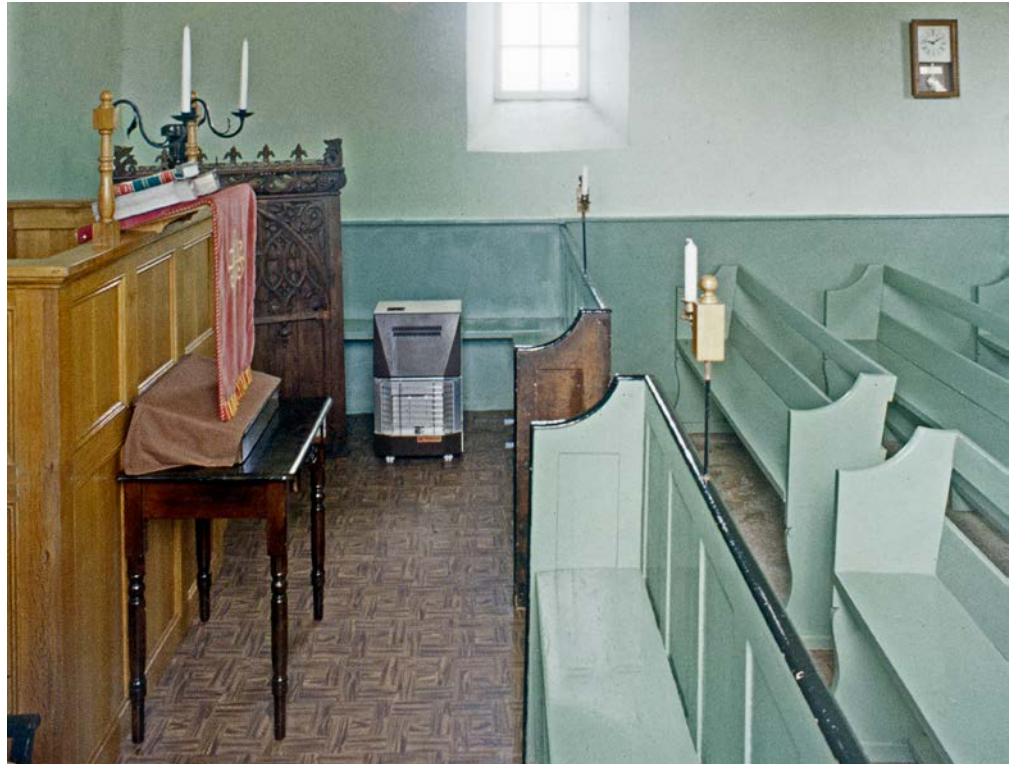
Figure 35:
Rare examples of benches
in the Bible Christian
chapel at Innis, Luxulyan.
This was built as a Quaker
meeting house in 1819,
and these painted benches
and the panelled leaders'
pews at the front were
installed in 1846 when it
was converted into a Bible
Christian chapel.
© Eric Berry

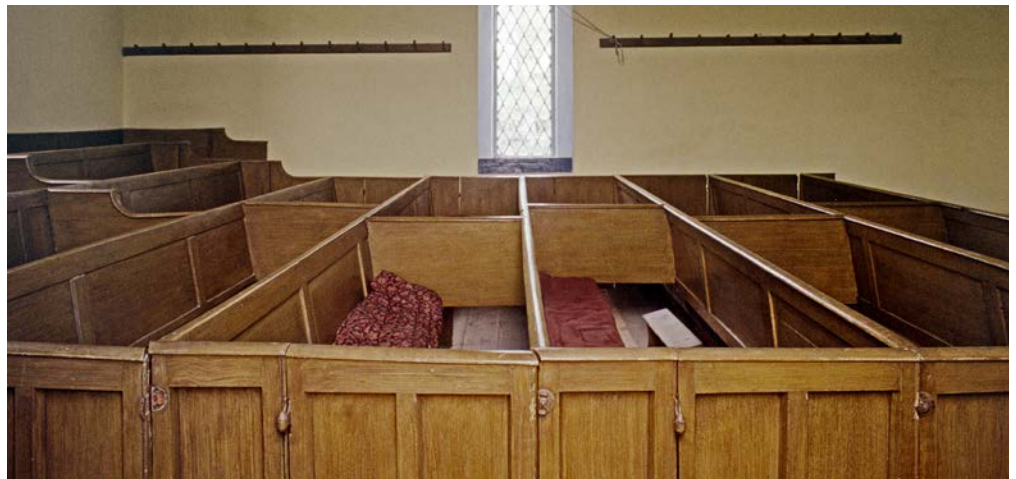
Figure 37:
The interior of the
1858 unlisted chapel at
Bugle was completely
remodelled and refitted in
1890. The pitch-pine pews
are of a standard design,
with v-jointed boards
and shaped ends with
ceramic numbers, but the
richly decorated panelled
and pilastered gallery
front is emphasised by its
architectural treatment.
© Eric Berry

- **Pews dating from the 1840s to the early 1900s**, which are the most common form of fixed seating. Stained or varnished pitch-pine pews replaced the plain deal pews with grained finish in many churches and chapels. These sometimes incorporate parts of cut-down box pews.

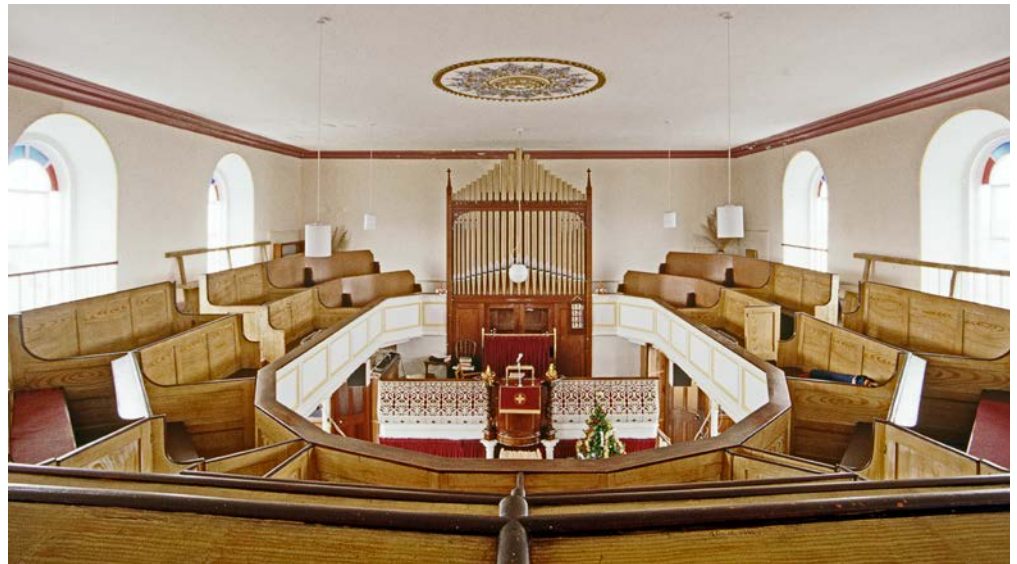
Figure 38:
 Gallery pews with grained decoration in the 1860 Wesleyan Reform Union chapel at St Just (Grade II). The photograph also shows the fine ceiling rose, and looks towards the organ loft set above the rostrum. This dates from 1895, and incorporates part of the original bow-fronted pulpit. The organ is possibly later.
 © Eric Berry

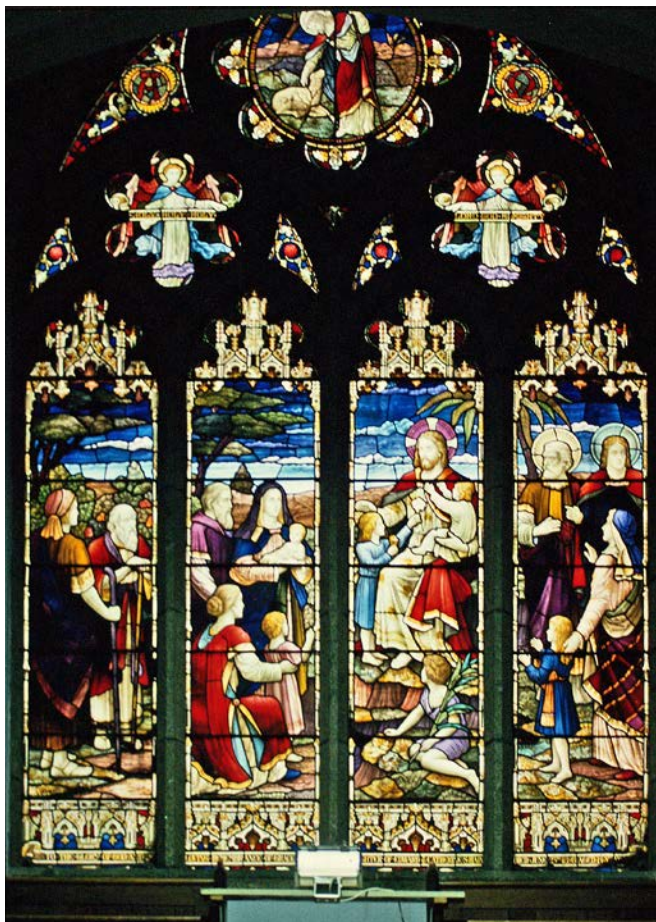
Figure 39:
 Pictorial stained glass with naturalistic decoration, representations of church saints, John Wesley and biblical scenes was used from the 1880s, but is far less common than in Anglican churches. © Eric Berry

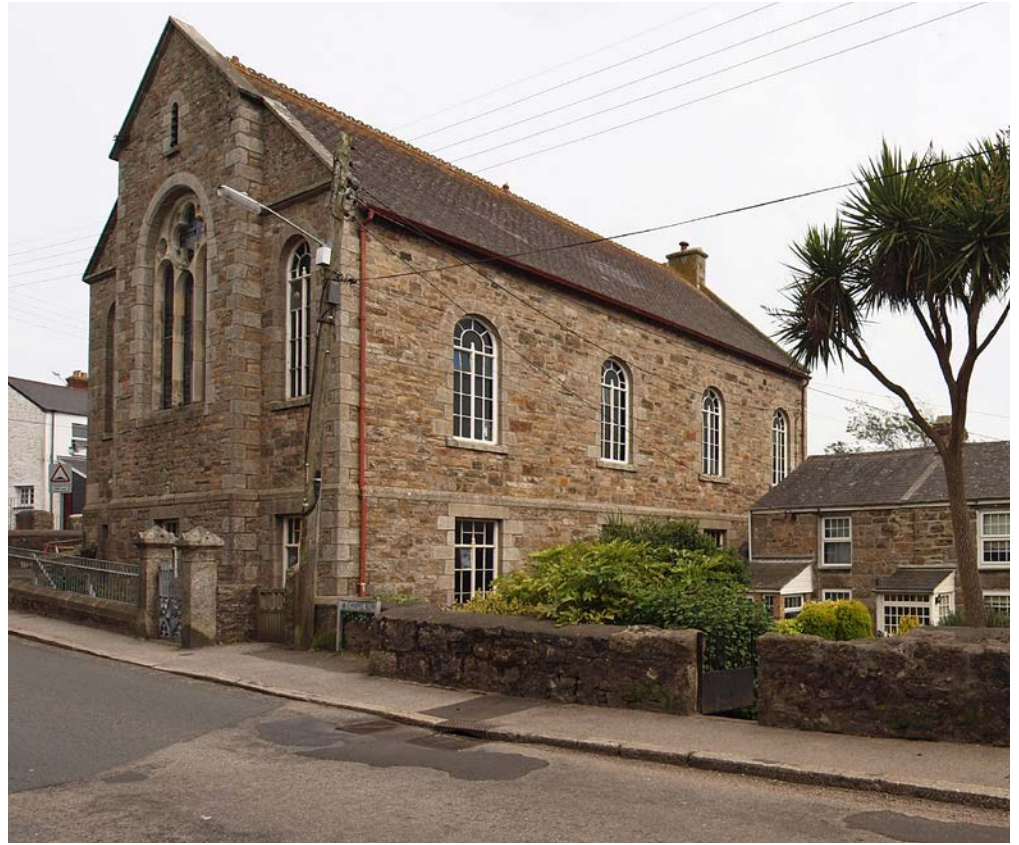
Figure 42:
The 1884 former Wesleyan chapel at Gulval (Grade II), now a studio, exemplifies a design type where the Sunday School and other rooms are accommodated within a basement underneath the chapel.
© Eric Berry

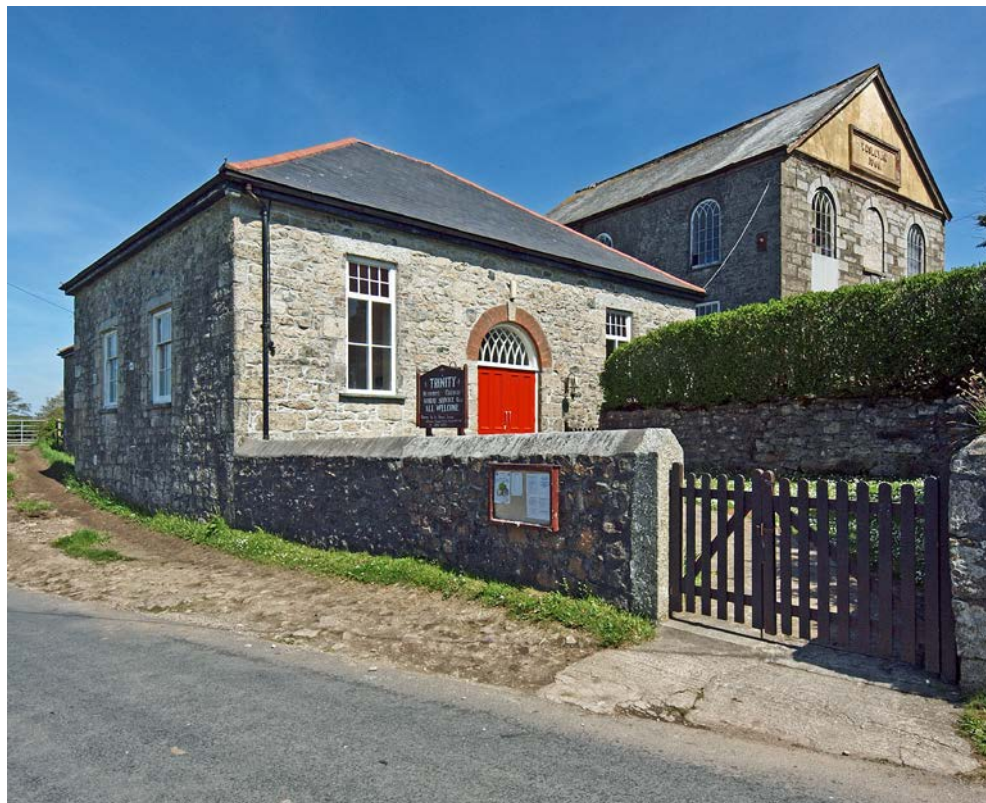
Figure 43:
At Porkellis, Wendron parish, the original chapel in the foreground was converted into a Sunday School (Grade II) when the 1866 chapel (Grade II*) was built. It is once again the chapel, and the larger chapel has been converted into a studio and residence.
© Eric Berry

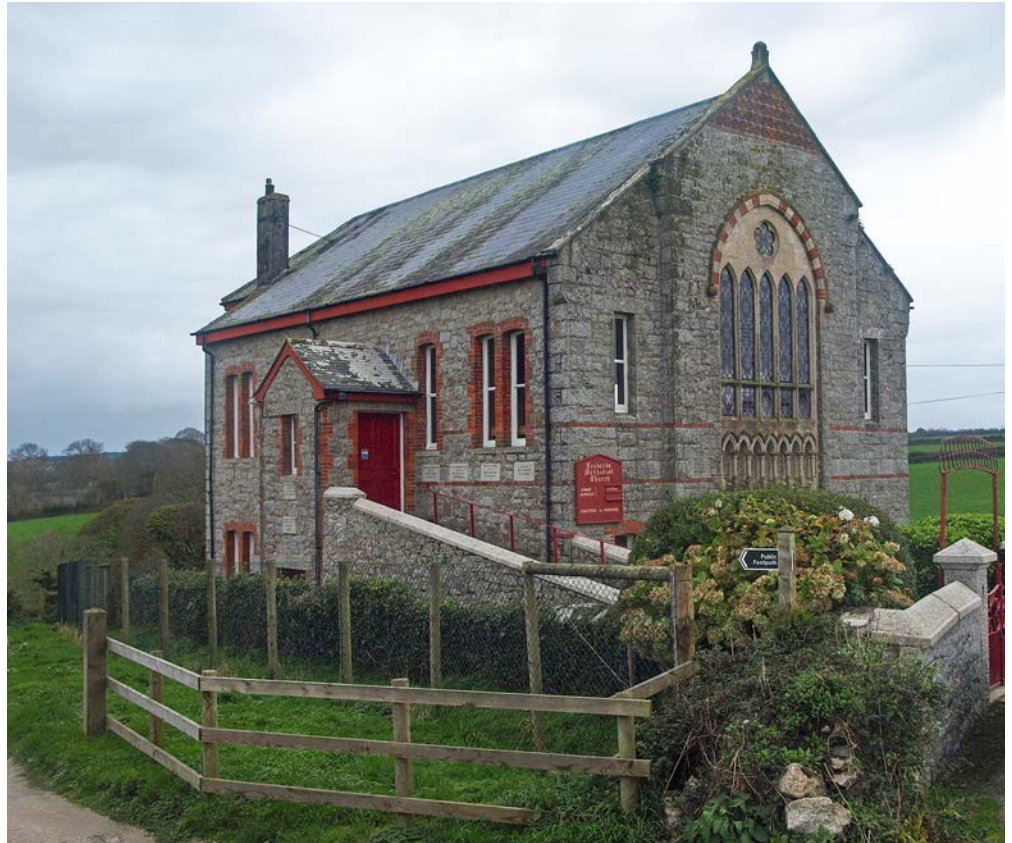
Figure 44:
The 1889 chapel (opened 1890) at Treverva in Budock parish (Grade II) is a further example where a Sunday School is sited underneath the main chapel.
© Eric Berry

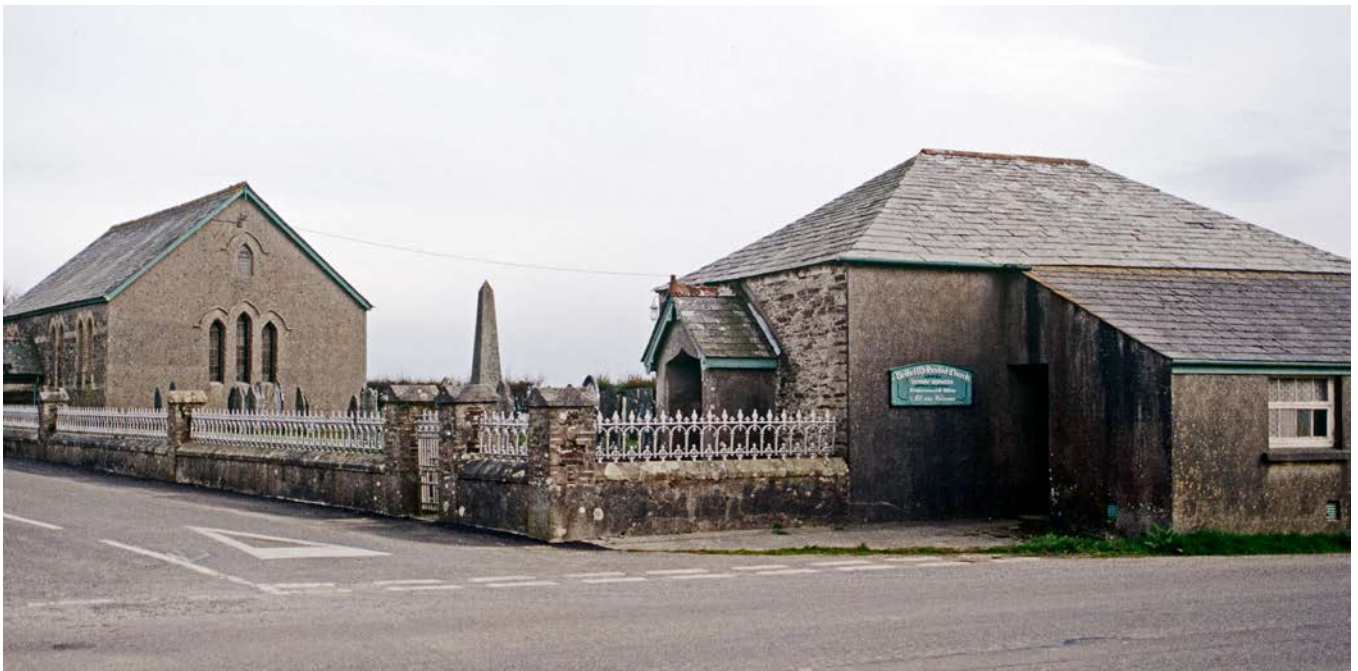
Figure 45:
At Treneglos, the original chapel of 1838 (Grade II), prominently sited on a crossroads, has been used as the Sunday School since the building of the Gothic-style chapel in 1881 (Grade II, to left). © Eric Berry

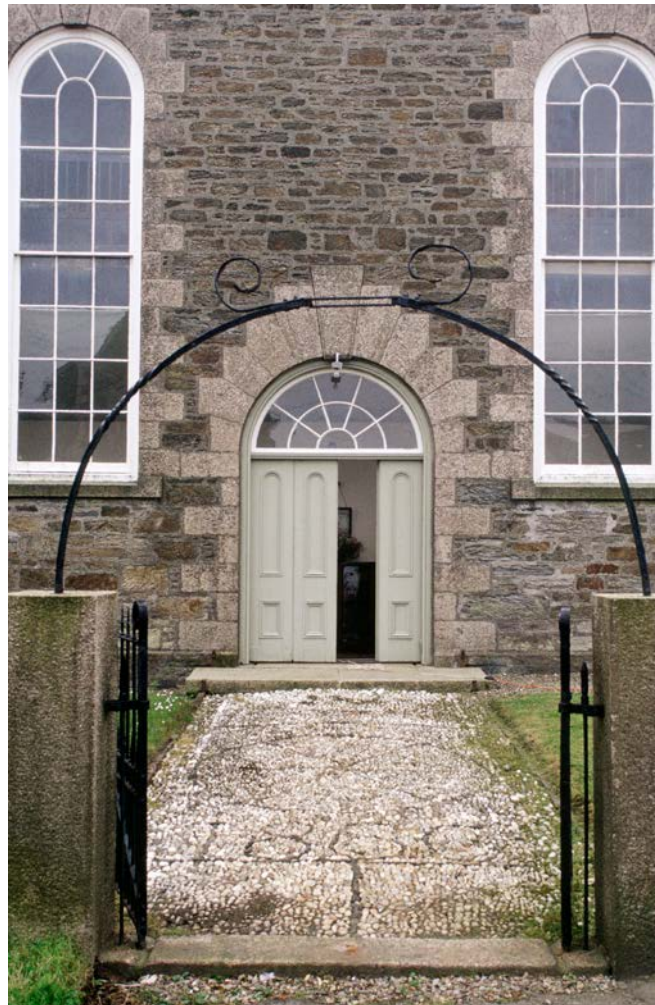
Figure 48:
The former Wesleyan chapel at Voguebeloth in Illogan (Grade II*) has a foundation stone of 1865 and the date 1866 picked out in the cobble pathway.
© Eric Berry

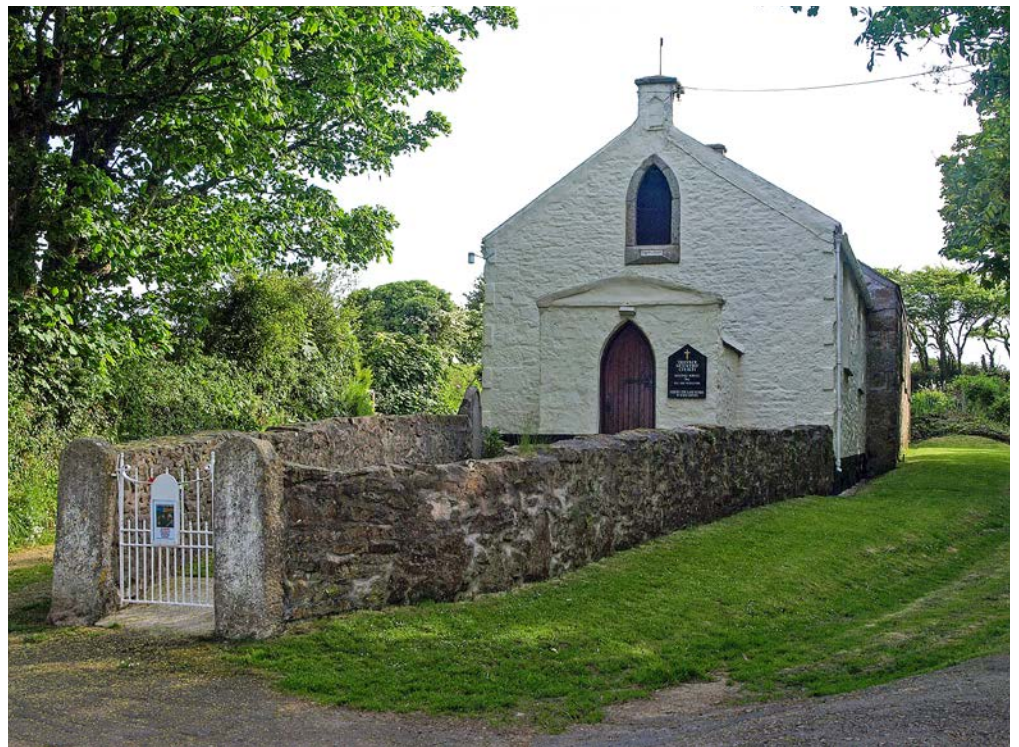
Figure 49:
Boundary walls surround the forecourt area to the small-scale vernacular chapel of 1844 (Grade II) at Tredavoe near Penzance.
© Eric Berry

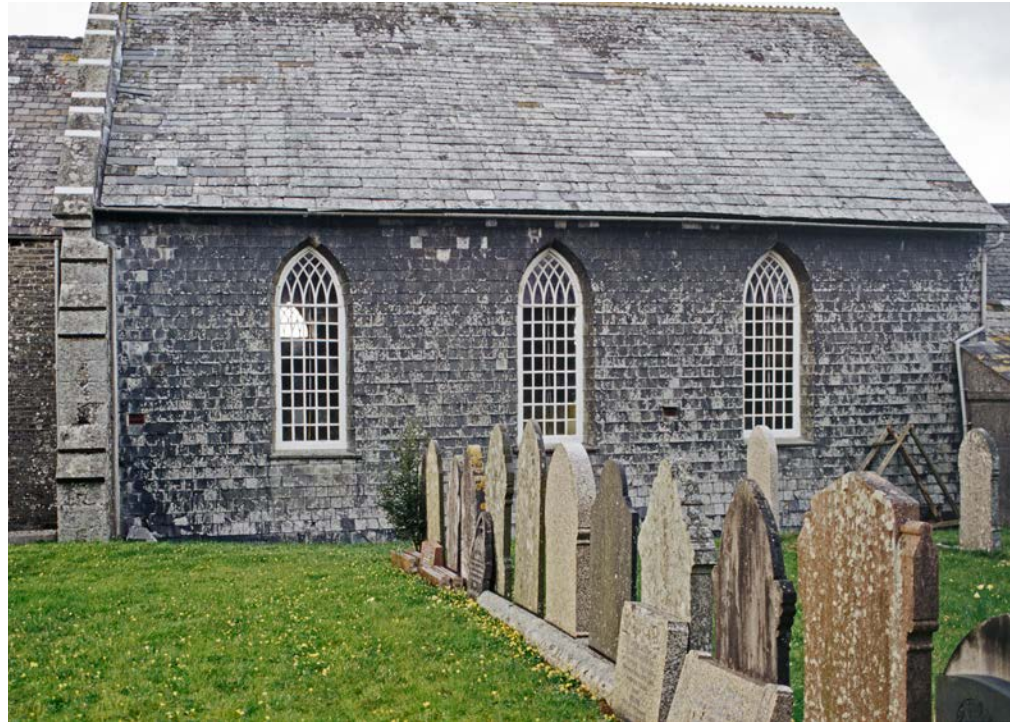
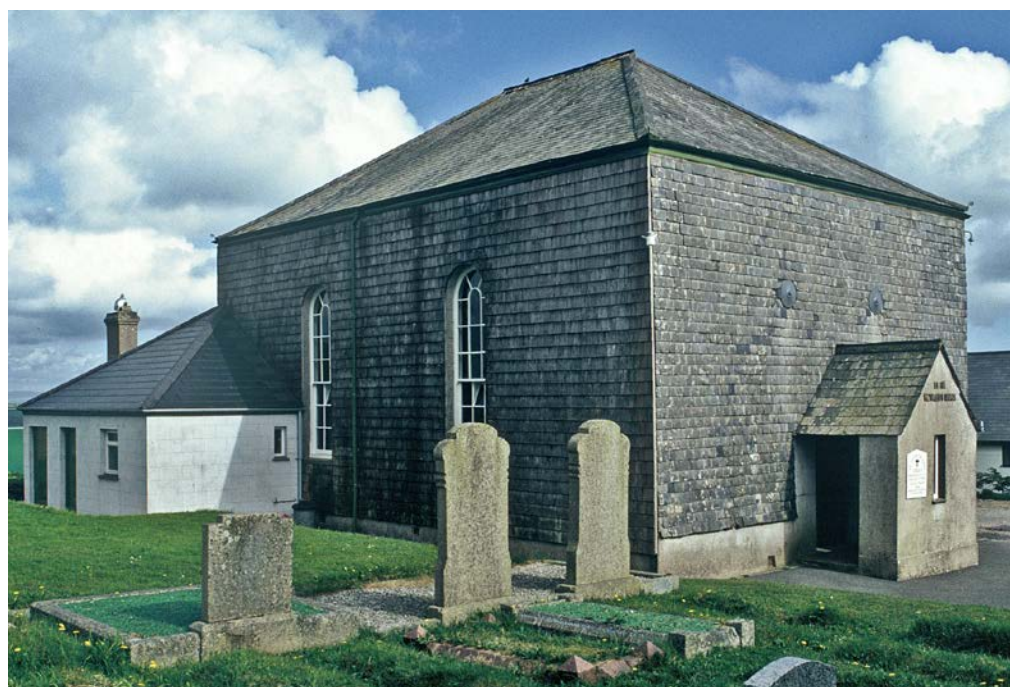
Figure 50 and 51:
Burial grounds comprise
the settings to the Grade
II listed chapels at Coads
Green, North Hill (top), and
St Ive (bottom).

Separate burial grounds are rare. They contain important evidence for Methodist social history, including the tombs of prominent society members and of families who either still live close by or whose descendants seek them out.
