Historic England

Historic Fibrous Plaster in the UK

Guidance on its Care and Management

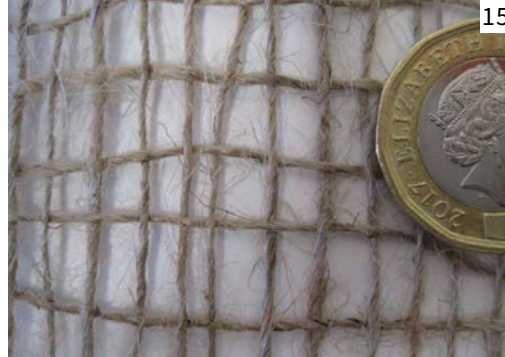
Figure 15: Modern hessian for producing traditional fibrous plaster, with a loose plain-woven fabric of twisted jute or hemp yarns. Plaster of Paris easily penetrates the widely spaced weave.

To make hessian, jute fibres are formed into threads that are woven into fabrics of different thicknesses and weights. With its natural fibres and loose weave, it readily allows both liquid water and water vapour to pass through it. Hessian performs several functions within a fibrous plaster cast:

- provides tensile strength to the cast
- holds timber laths in position within the cast
- forms ties, or wads, to fix the panels to structure above
- laps joints between adjacent panels

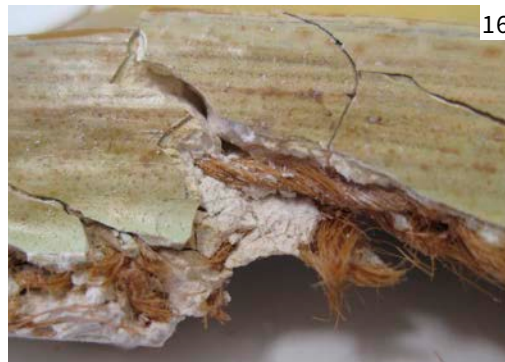
Figure 16: Section through historic fibrous plaster.

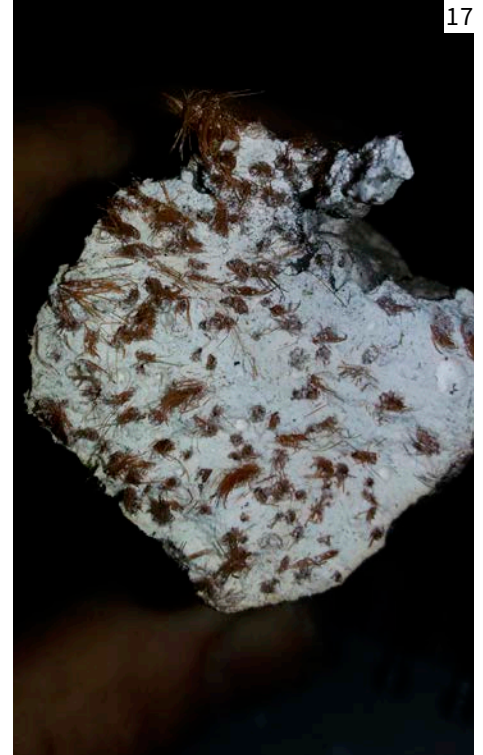
Figure 17: Section through a typical fibrous plaster wad, without wire reinforcement.

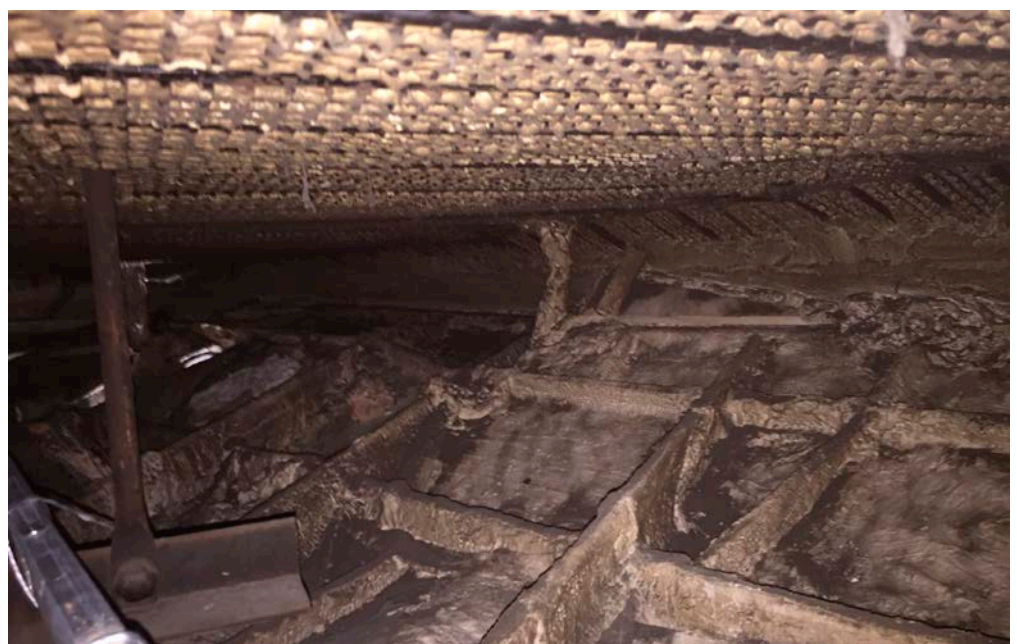
Figure 29: Large area of ceiling installed without sufficient wad connections to the panels. This can be easily detected in an inspection and remedied in subsequent repairs.

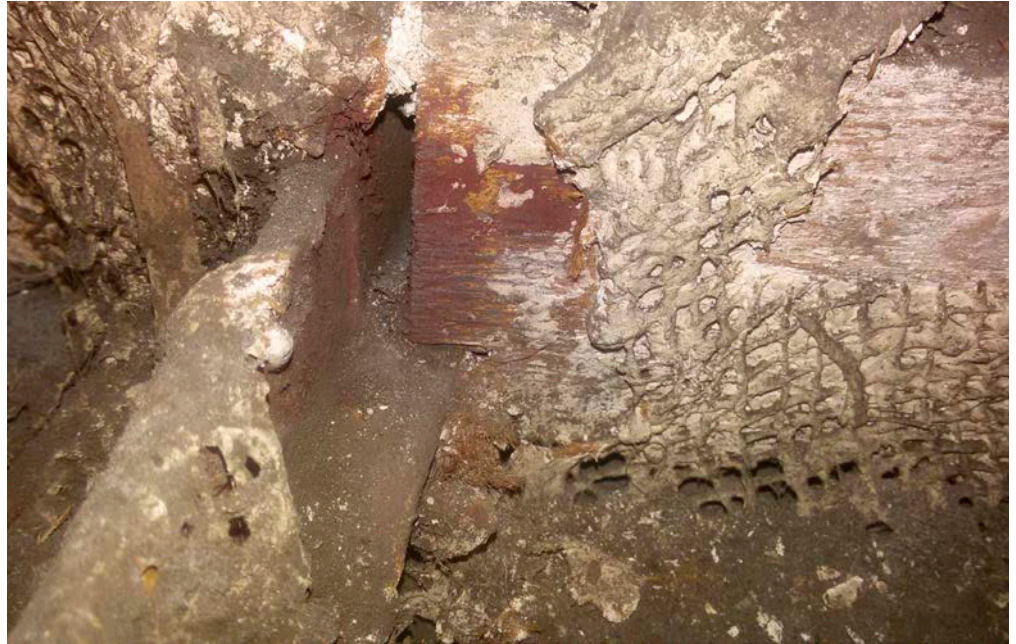
Figure 30: Poor bearing of a timber ceiling joist on a small steel T bar. The hessian has insufficient plaster cover to protect it from degradation. This illustrates how defects can be concentrated.

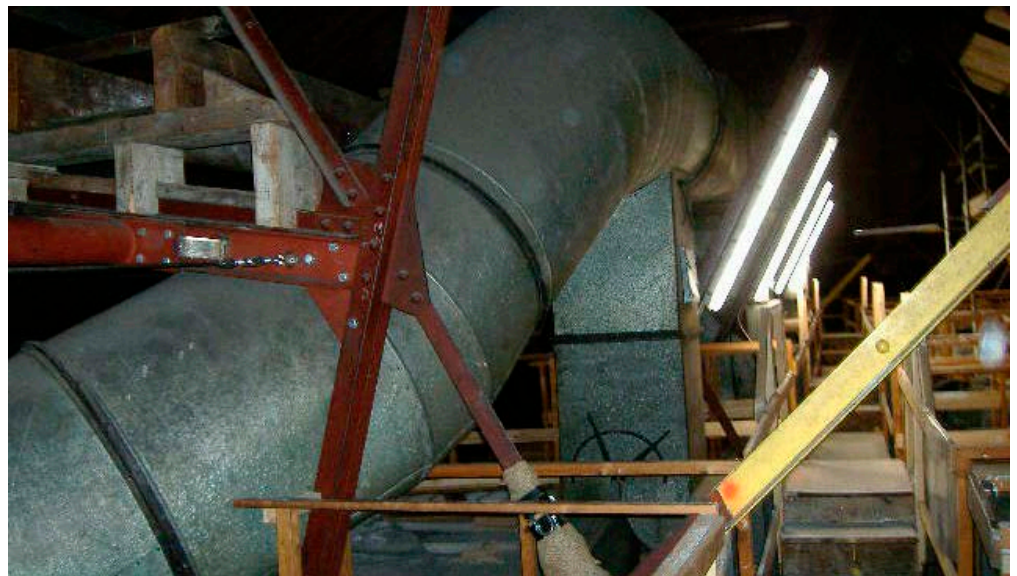
Figure 31: In ceiling voids bulky mechanical plant and boarded walkways (lower right) obscure the fibrous plaster ceiling below and impede its inspection.

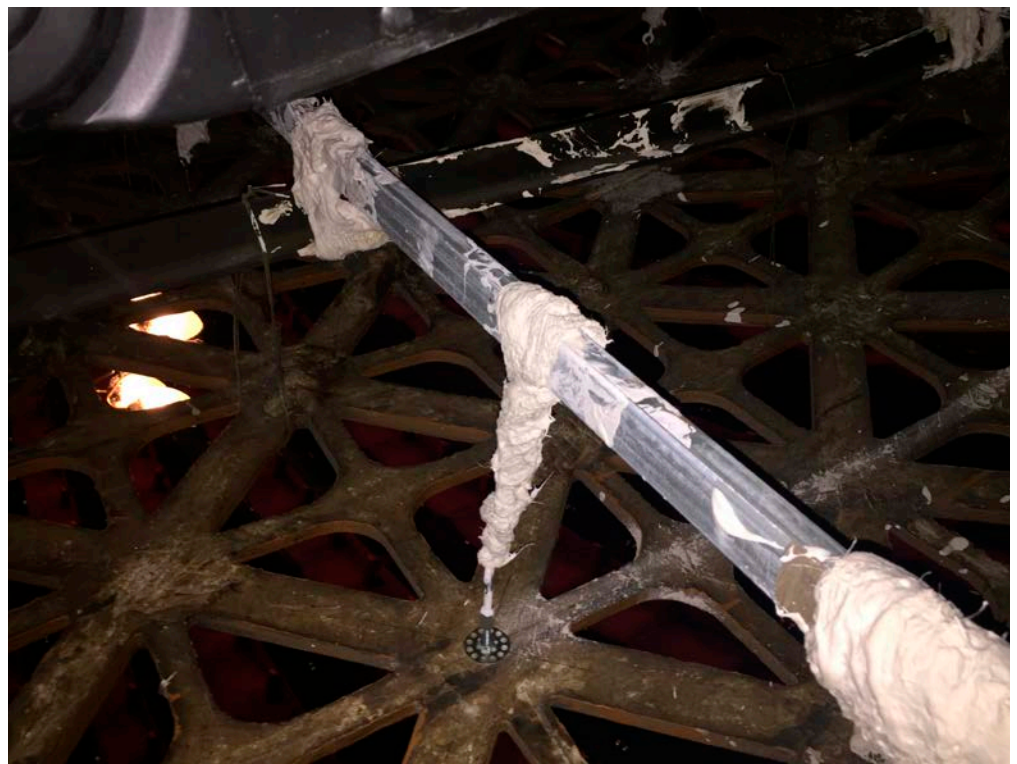
Figure 33: Fibrous plaster fretwork, given supplementary support with a new beam and wire-reinforced wads. This is a standard method of improving the stability of suspended ceilings.
