Tone Works

Wellington, Somerset

A Targeted Approach to Conservation Repairs
to Save a Heritage At Risk Site - A Case Study

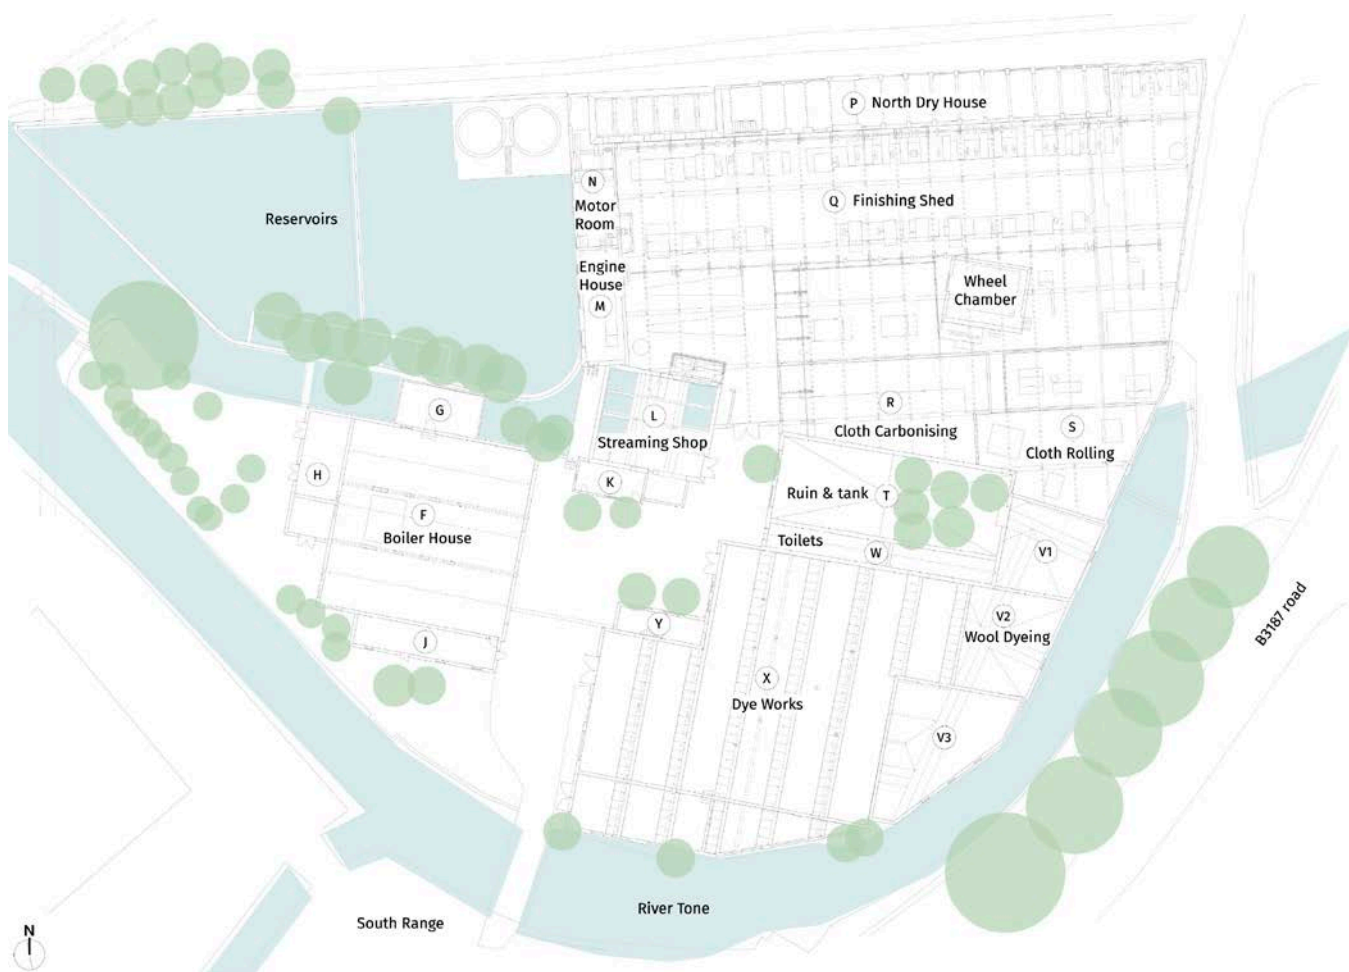
Figure 1: Plan of Tone Works, not to scale. © Architectural Thread Ltd

Drawing compiled by Thread with reference to survey Plan of the Finishing Works (2007) by Nigel Fradgley and Mike Williams in Lucy Jessop, Tone Works, Wellington, Somerset: Survey and Analysis of Buildings, Power Systems and Machinery Volume Two: Appendices, English Heritage Research Department Report Series, 72/2007; and Site Location Plan and Key to Buildings (2016) by Harrison Brookes Architects.

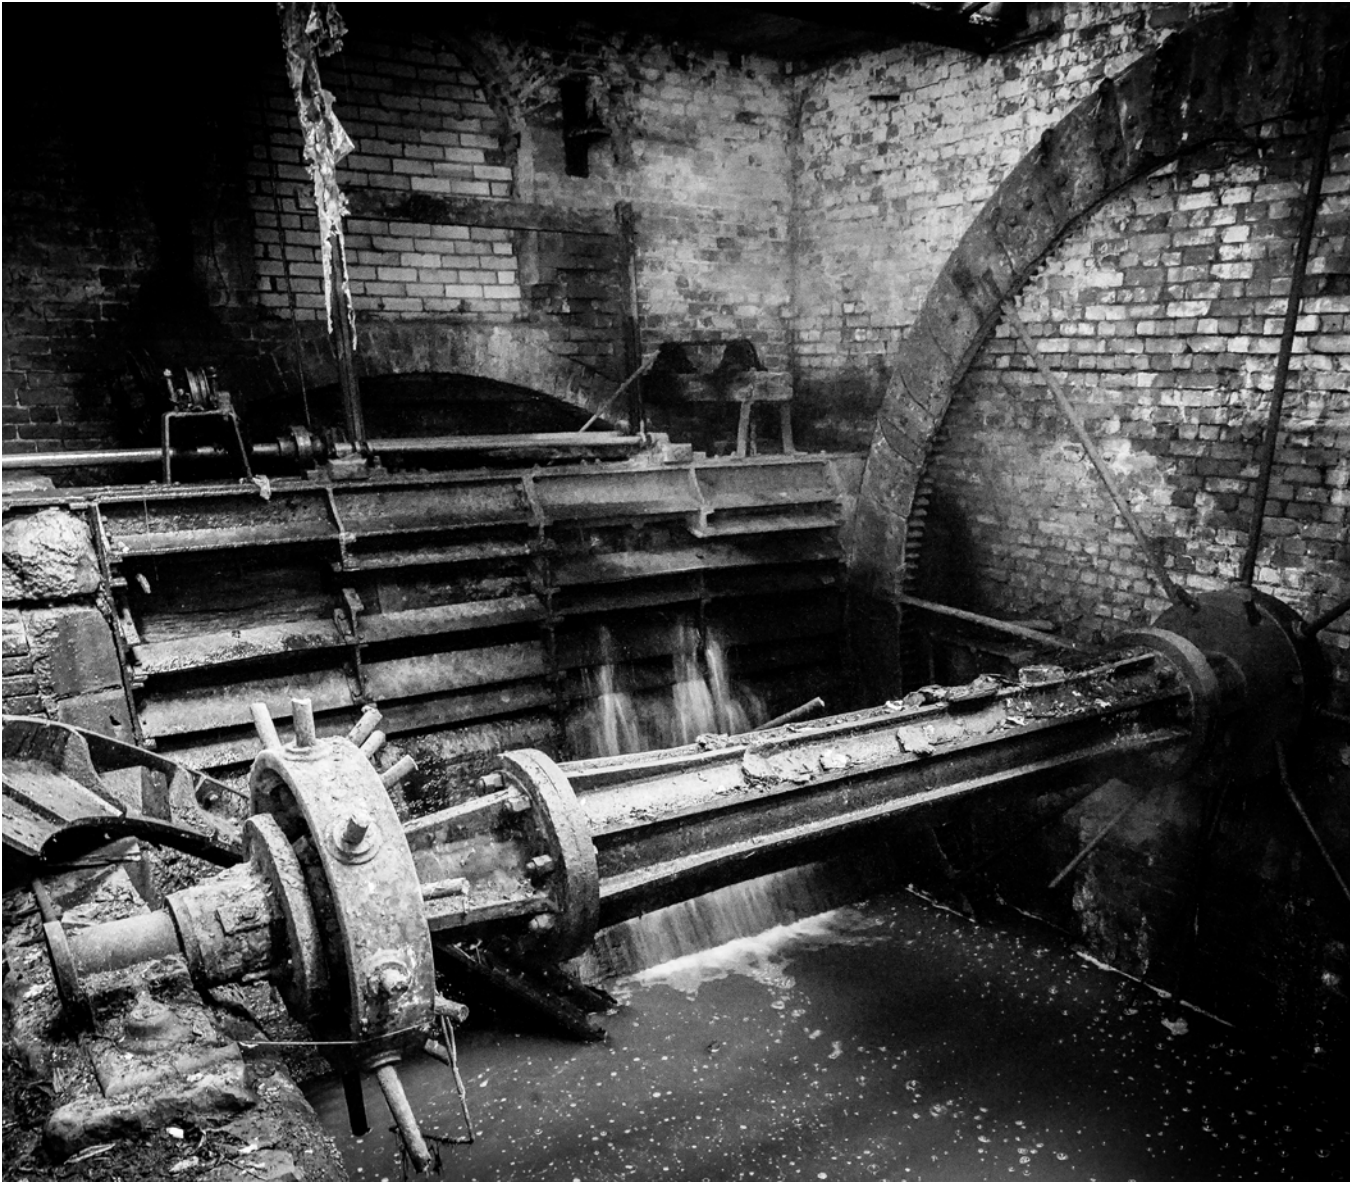
Today, the Wheel Chamber consists of the remains of the early 19th-century water wheel and power system, situated on an earlier lower floor level before the Finishing Shed floor was built up around it. The water channels that run through (culverted below) the Finishing Shed floor are now silted up. However, they appear to have followed the arrangement shown on the tithe maps of 1839, feeding the breast-shot suspension wheel’s buckets (no longer present). The end walls (in handmade red bricks) above the [head and tail race](#) date back to the early 19th century, while the side walls (of factory-made bricks) and flat roof were built later, when the Finishing Shed was constructed. The Wheel Chamber contains evidence of water and steam power transmission.

Figure 2: Wheel Chamber. © Claire Fear

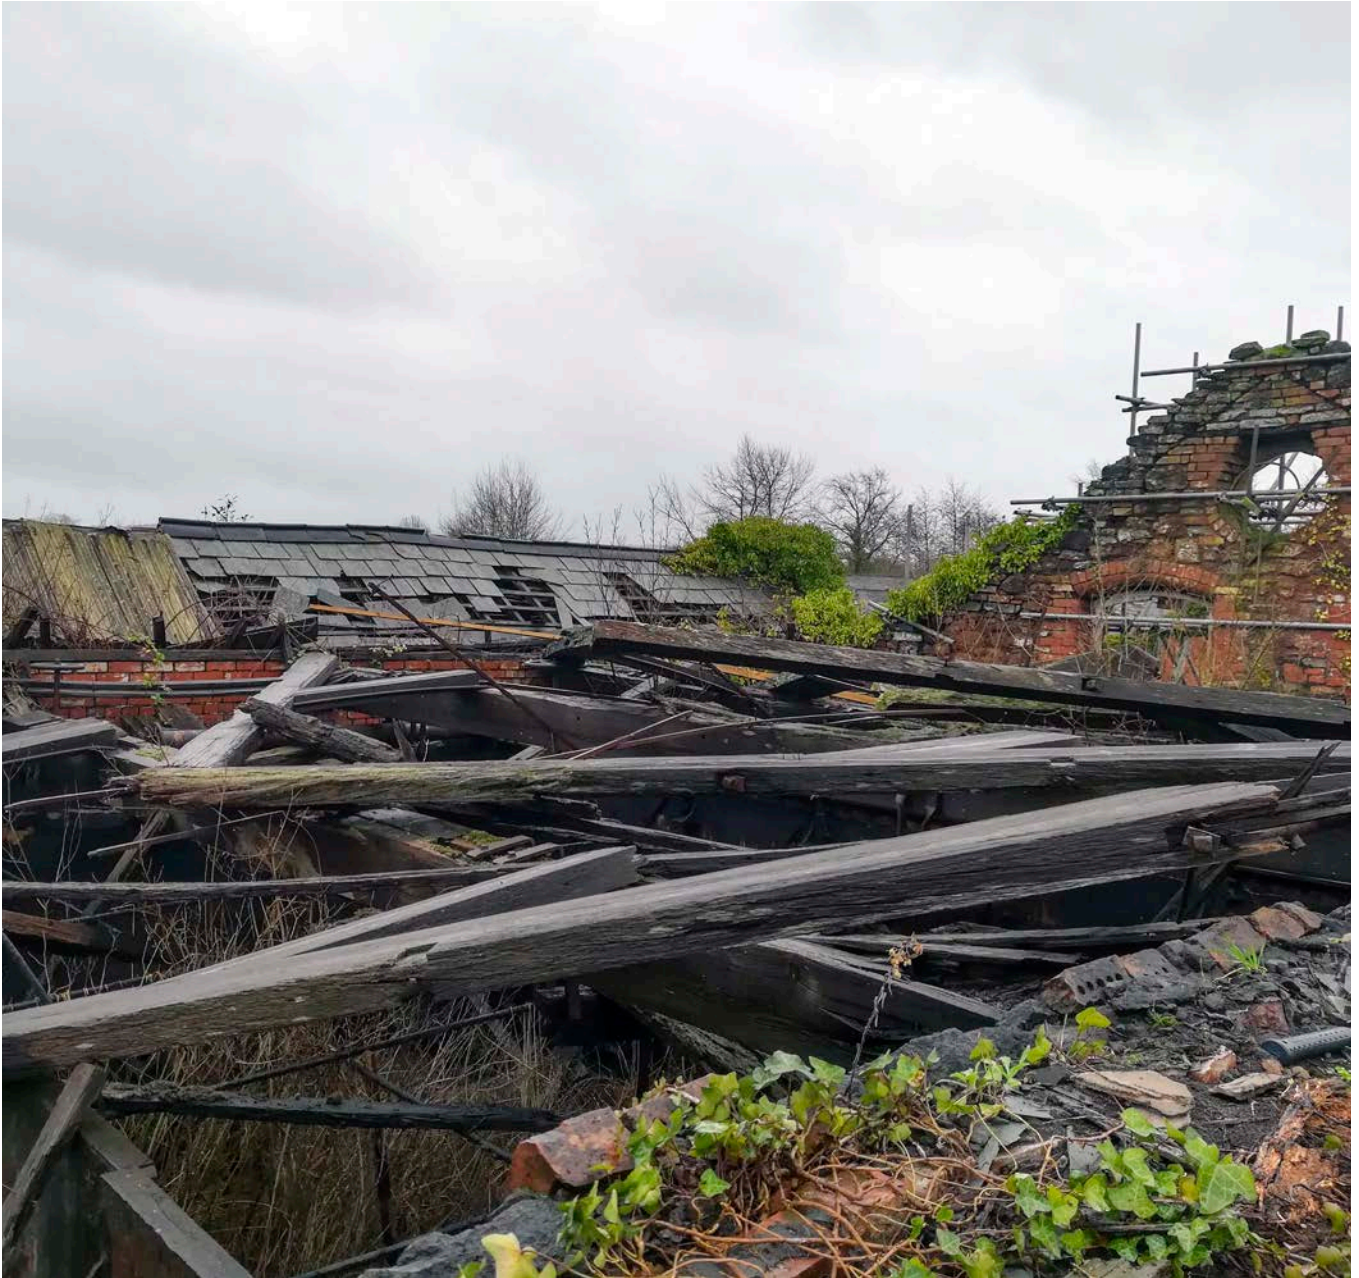
Area T houses a large elevated cast-iron tank, supported by cast-iron columns and substantial timber beams. The ends of the beams can be seen on the other side of the wall in Area R. The English Heritage 2007 report notes that this tank was once used for storing treated water for the Dye Works, and was later used as an oil tank.⁶ This was confirmed when the tank was drained in 2022 after testing the water in it for contaminants and a thick oily substance was found at the bottom. Areas of the wall between Areas T and R appear to be older than the main facade. Several phases of rebuilding are apparent in the wall fabric. It is possible that some of these sections relate to the early 1754 phase of the site, but this has not been confirmed.

Figure 4: Collapsed structure over cast-iron tank in Area T. © Vanessa Ruhlig

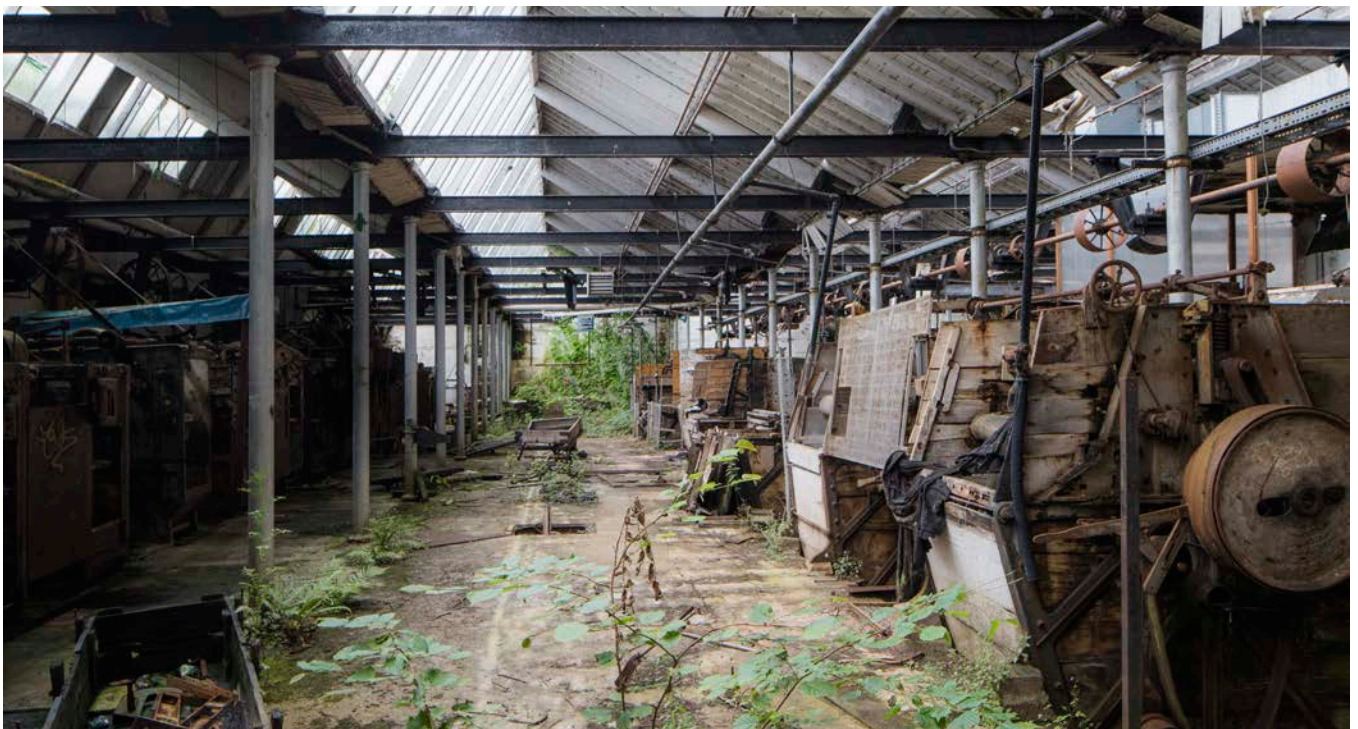
Figure 7 (bottom): Finishing Shed interior in 2020/2021, showing rows of machines as in 1912. © Claire Fear

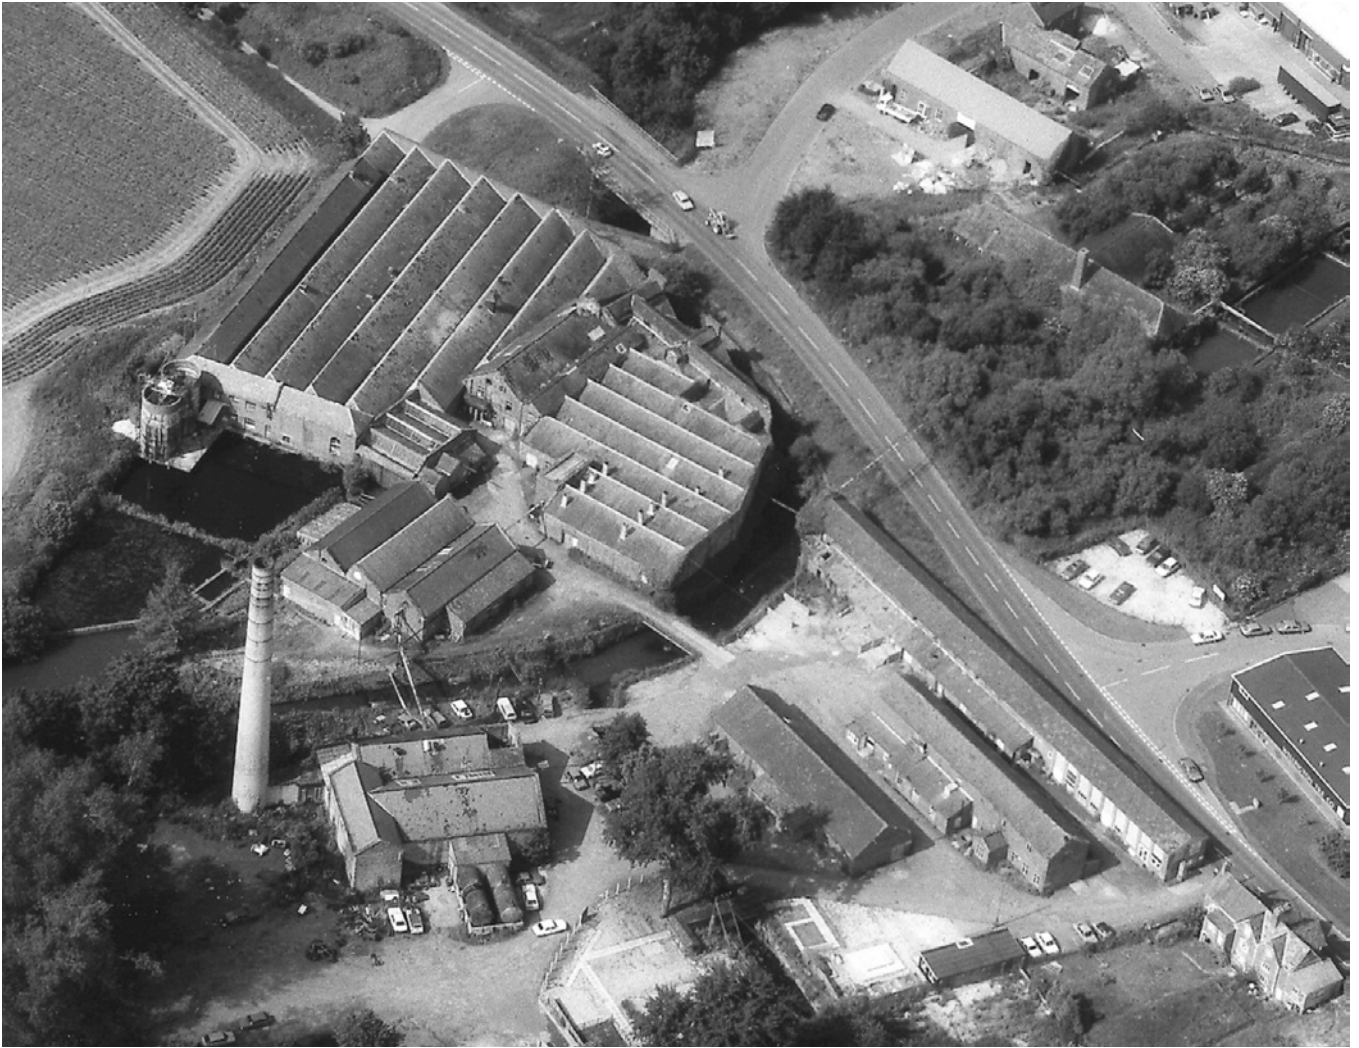
The English Heritage 2007 report includes an aerial photograph of Tone Works, dated 1995, which shows the condition of the roofing at the time. Notably, the roof over Area T appears to be largely intact but shows signs of degradation. English Heritage reports that the site was still operational in 1995, when the Royal Commission on the Historic Monuments of England (RCHME) recorded the buildings.

Figure 8 (top): 1995 Aerial photograph of Tone Works, showing roof still over area T. © English Heritage/Historic England

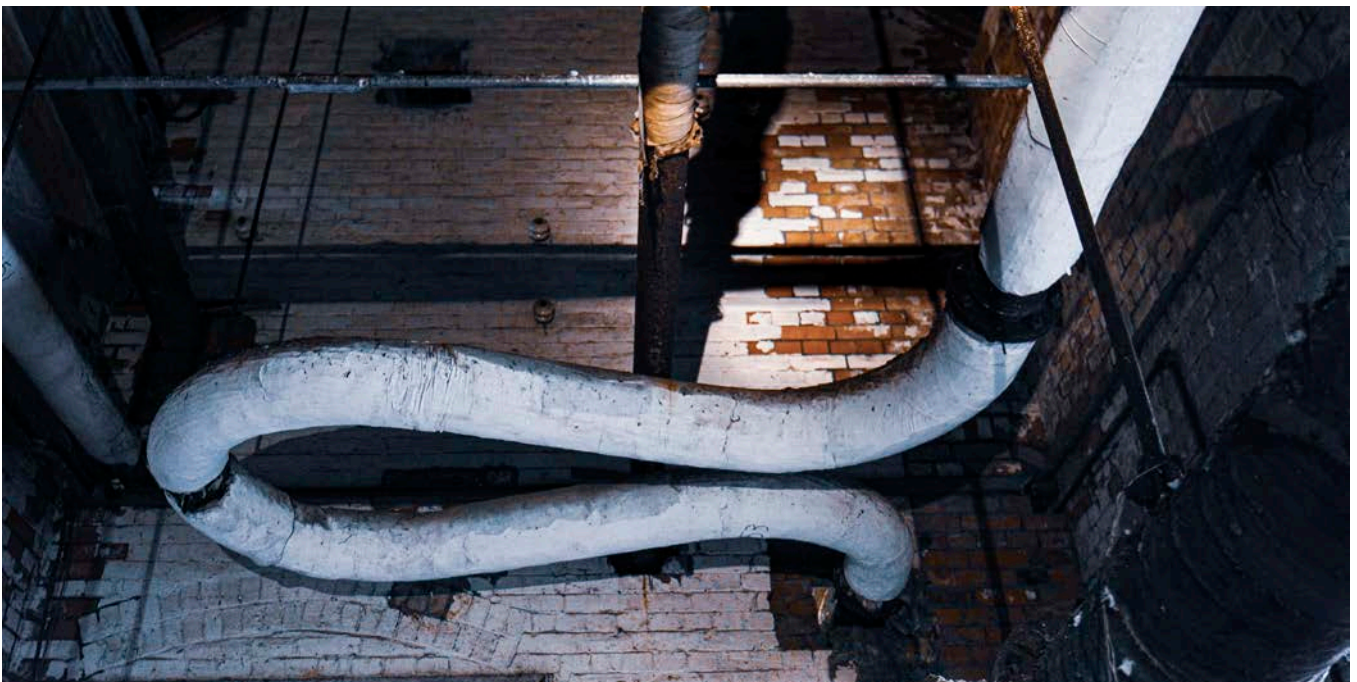
Casa Environmental Services compiled an asbestos refurbishment report after surveying the entire site on 26 August 2020. A total of 339 samples of suspected asbestos-containing materials were taken and analysed.³⁵ The poor condition of the buildings had led to the deterioration of most of the asbestos insulation and lagging to pipework. This was found in the form of loose debris across the floors, ledges and high-level surfaces. It was presumed to be in low-level culverts and machinery as well. The report recommended restricted access to the areas that contained asbestos and the immediate removal of all debris. The spread of debris and extensive number of samples meant that the recommendation applied to all the buildings on the site.

Figure 10: Example of asbestos pipe lagging and insulation, 2021. © Claire Fear

Due to the severe risk to human health within these contaminated areas, no works could be undertaken on the site until the identified items had been removed or [encapsulated](#) by a licensed asbestos contractor, in accordance with [HSE](#) regulations and the Control of Asbestos Regulations 2012.

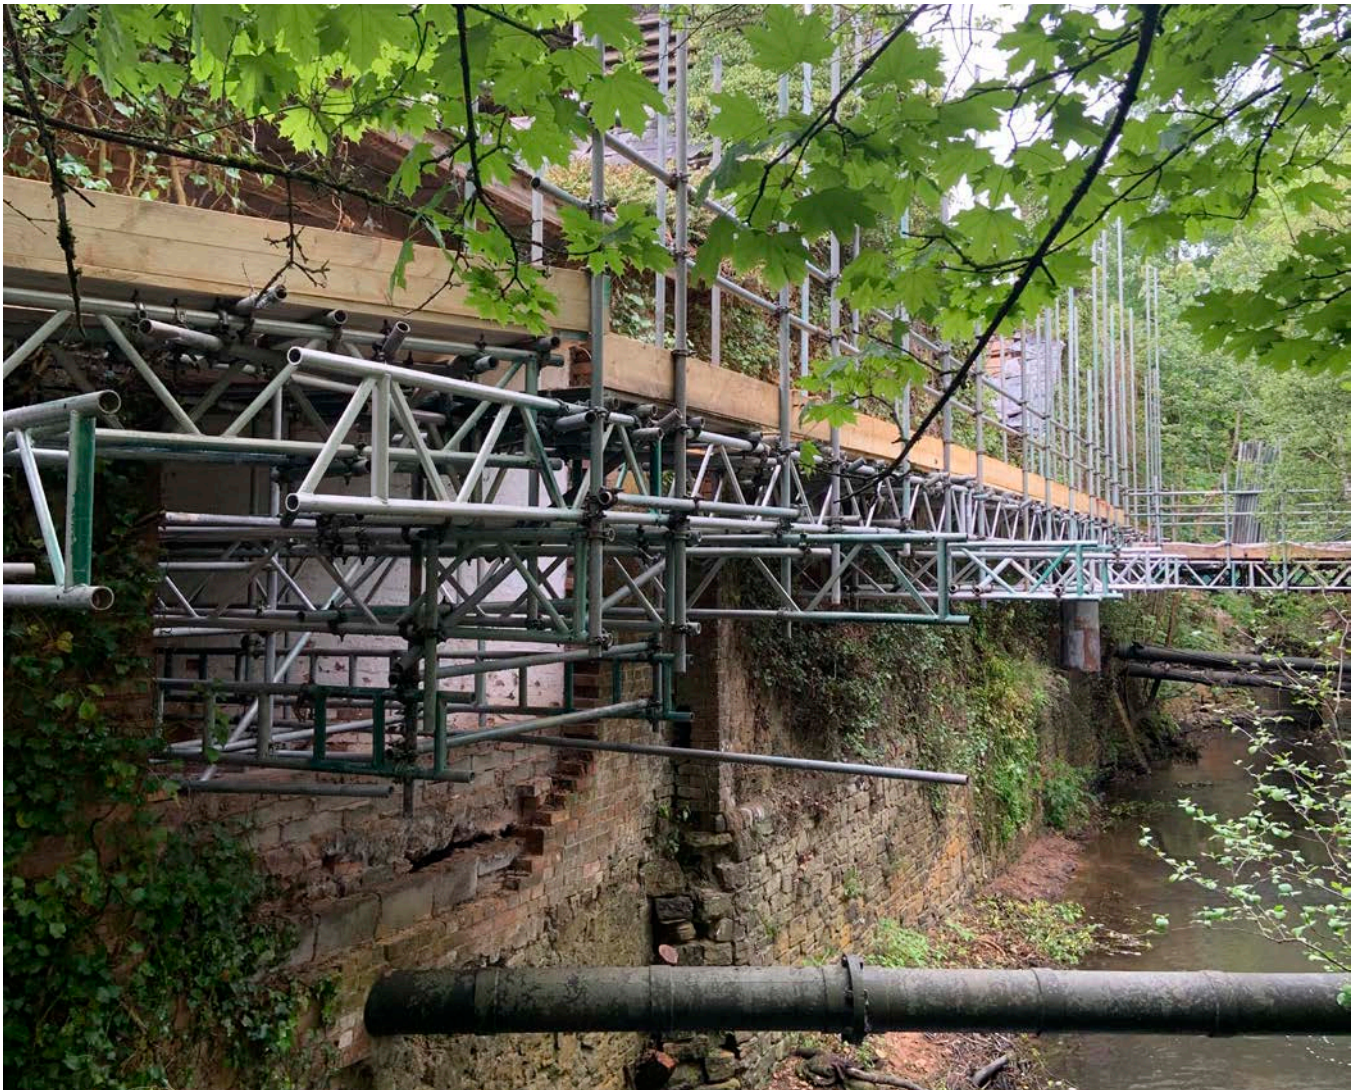
For repairs to Area V in 2022, a projecting cantilevered scaffold structure and access bridge was built over the river to provide safe high-level access to the masonry and roof. This was designed by a specialist scaffold firm, Optima Scaffold Designs. The company had already designed emergency propping to provide internal structural support in areas identified by the structural engineer in 2021 and was, therefore, familiar with Area V.

To provide access to all roof areas, the scaffolding had to span floors that had several voids, below-ground tanks and uneven subsiding floor surfaces. A ‘birdcage’ scaffold structure was developed to provide an extensive grid of standards on baseplates, to spread the load over the floor area. It also accommodated the existing temporary propping, so this did not need to be removed until repairs were completed. The ‘birdcage’ supported a series of cantilevered beams taken out through existing window openings to support a narrow

external access scaffold, which ran along the edge of Area V above the river. In this way, none of the scaffold touched the river or river bed, in line with Environment Agency requirements. The external access scaffold also provided netted protection to stop any waste or loose materials falling into the river. This was an important consideration because of the risk of contaminating the river.

Figure 11: Cantilevered scaffold and bridge over river, 2022. © Claire Fear

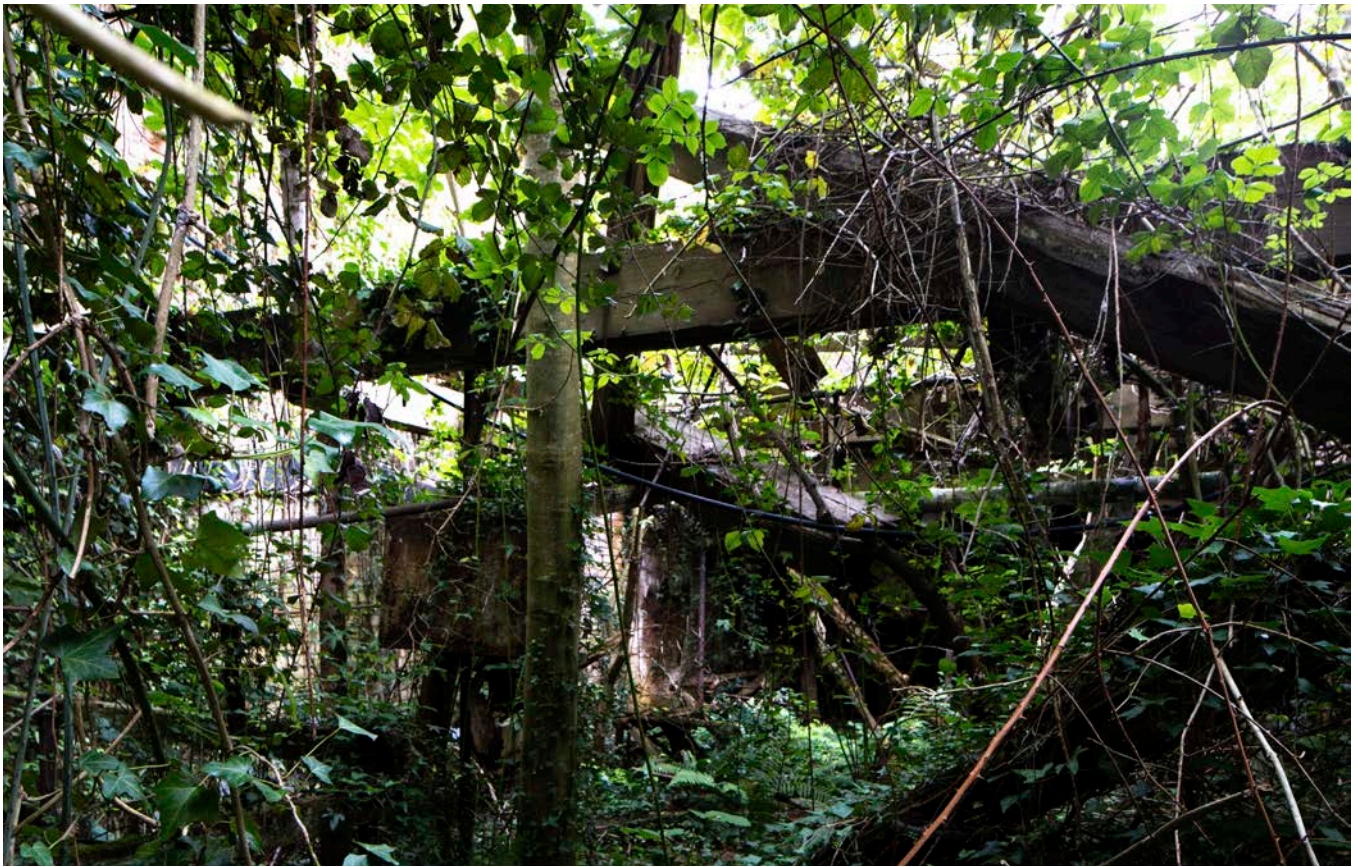
The lack of maintenance in the past had led to dense vegetation growing on the exterior of the buildings, and inside areas where roofing had failed. The extent of ivy and brambles meant that visibility in some areas was severely lacking. This affected the surveys because not all areas could be fully accessed or viewed, and the condition of the building fabric behind the vegetation could not be fully assessed.

Figure 12: Overgrown vegetation in Area T concealing voids and failed structure, 2021. © Claire Fear

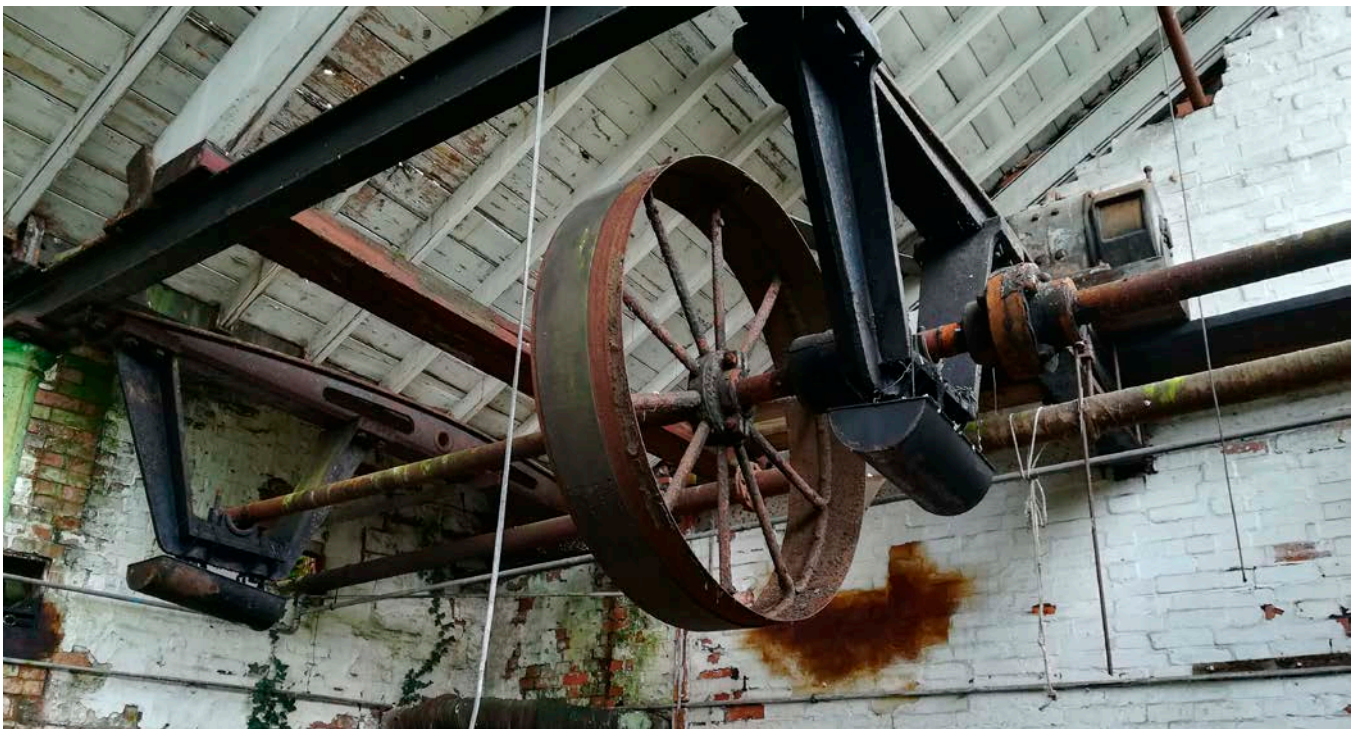
Asbestos decontamination projects typically remove contaminated lagged pipework and intricate machinery to eliminate all asbestos from the site. This was not possible at Tone Works because of the historic significance of the machinery and artefacts. The contractor had to work around these items to conserve the historic fabric. Ultimately, all accessible asbestos was either carefully removed, where this did not damage historic items, or encapsulated *in situ* to seal and protect it.

Figure 13: Example of overhead line-shafting, belt drive and oil trays, 2021. © Vanessa Ruhlrig

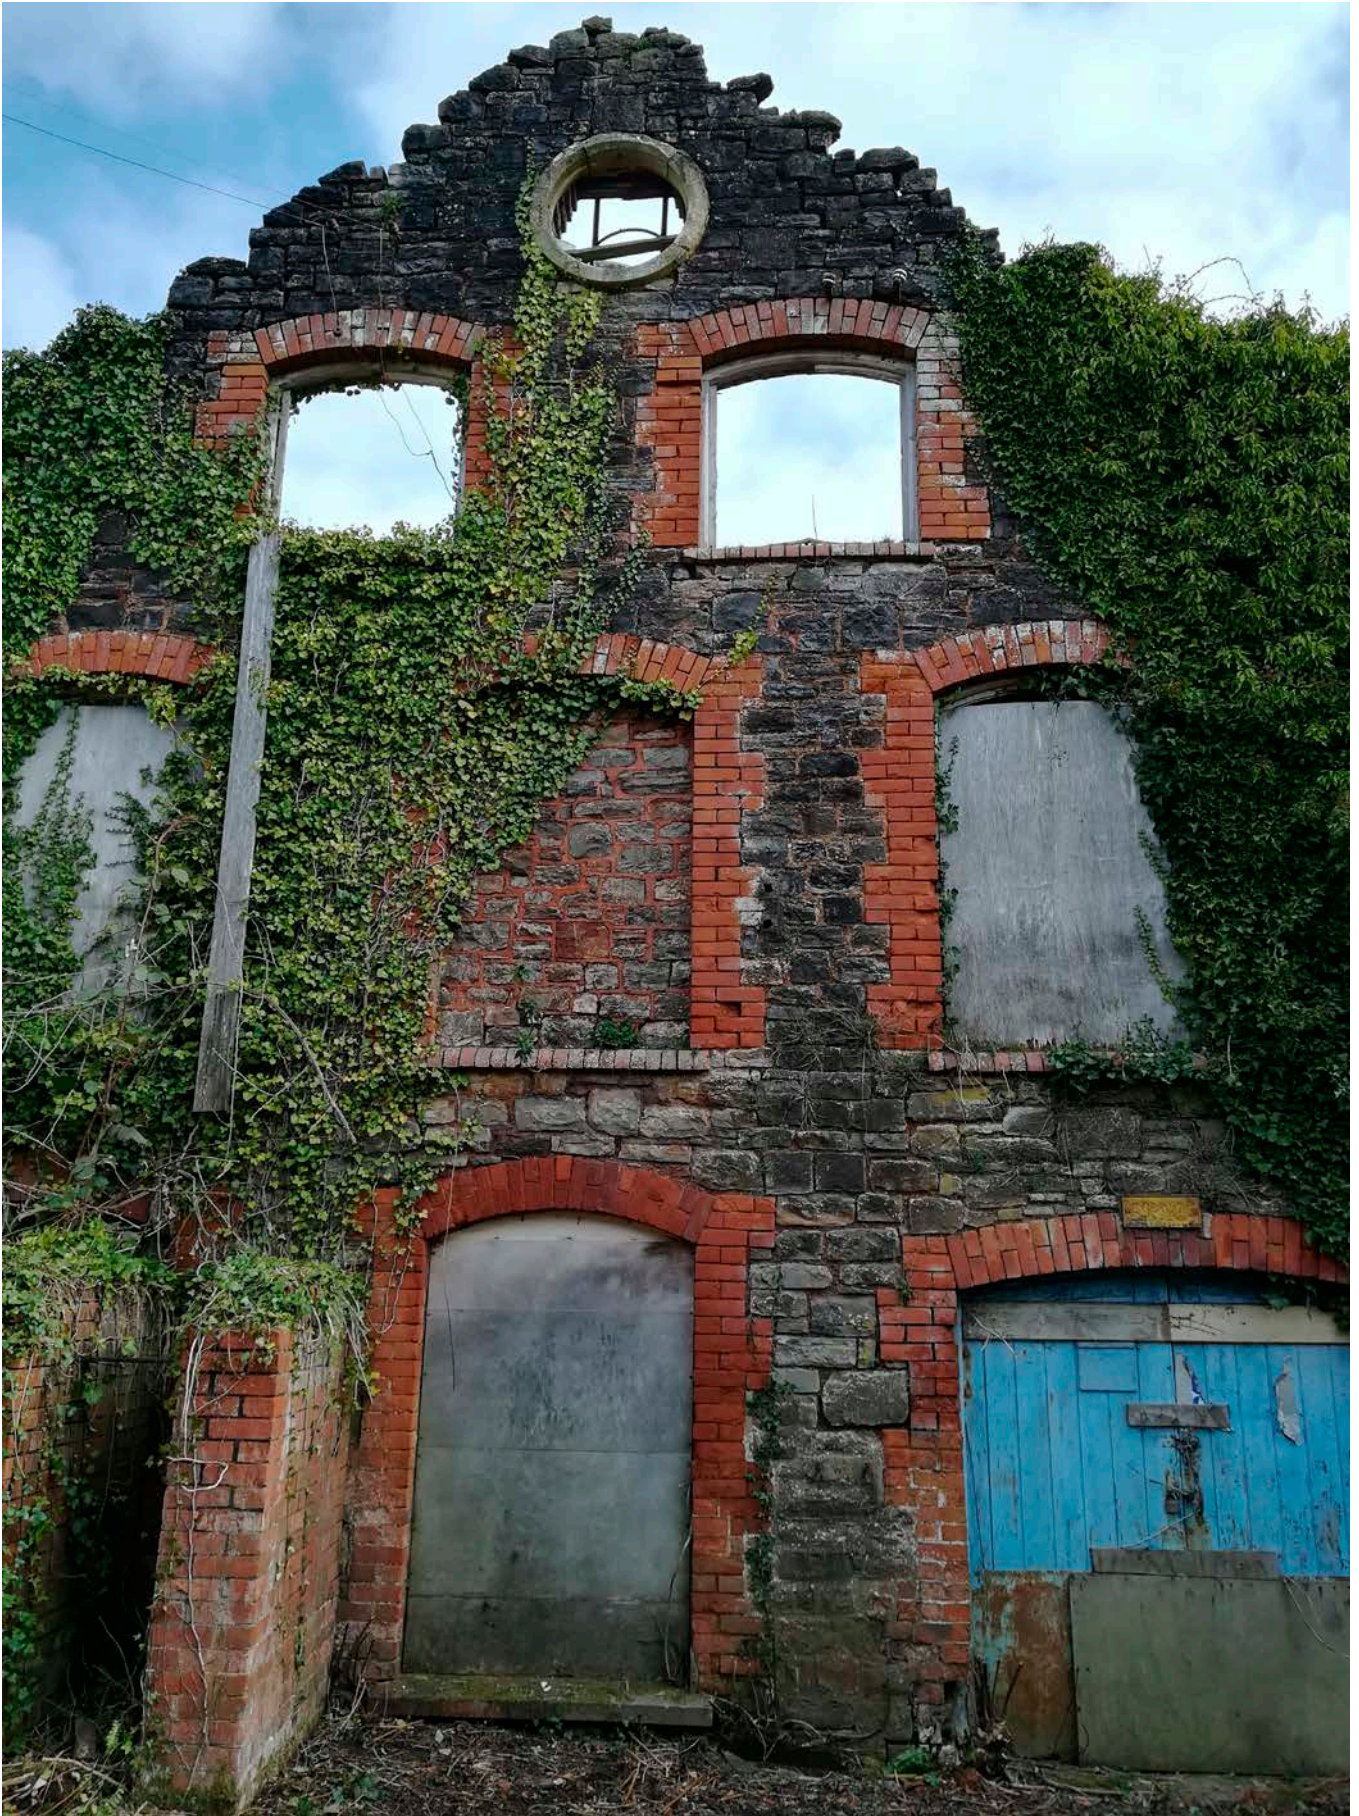
The degradation of the buildings at Tone Works had reached the stage where any further delays to repairs would cause an exponential increase in deterioration. For example, in Area T, a photograph dated 1995 shows the roof and clock still in place.³⁸ Some 20 years later, the Harrison Brookes Architects condition surveys note that although little was left of the roof in Area T, the trusses were still in place, in both 2015 and 2018.³⁹ By 2021, only three years later, these trusses had collapsed into the vegetation below. Decision-making to facilitate repairs, therefore, had to be swift to help save the rest of the buildings. The Heritage at Risk project team at the Council played an essential role in enabling these decisions to be implemented.

Figure 15: 2021 photograph of Area T gable, showing severe deterioration, loss of clock. © Vanessa Ruhlig

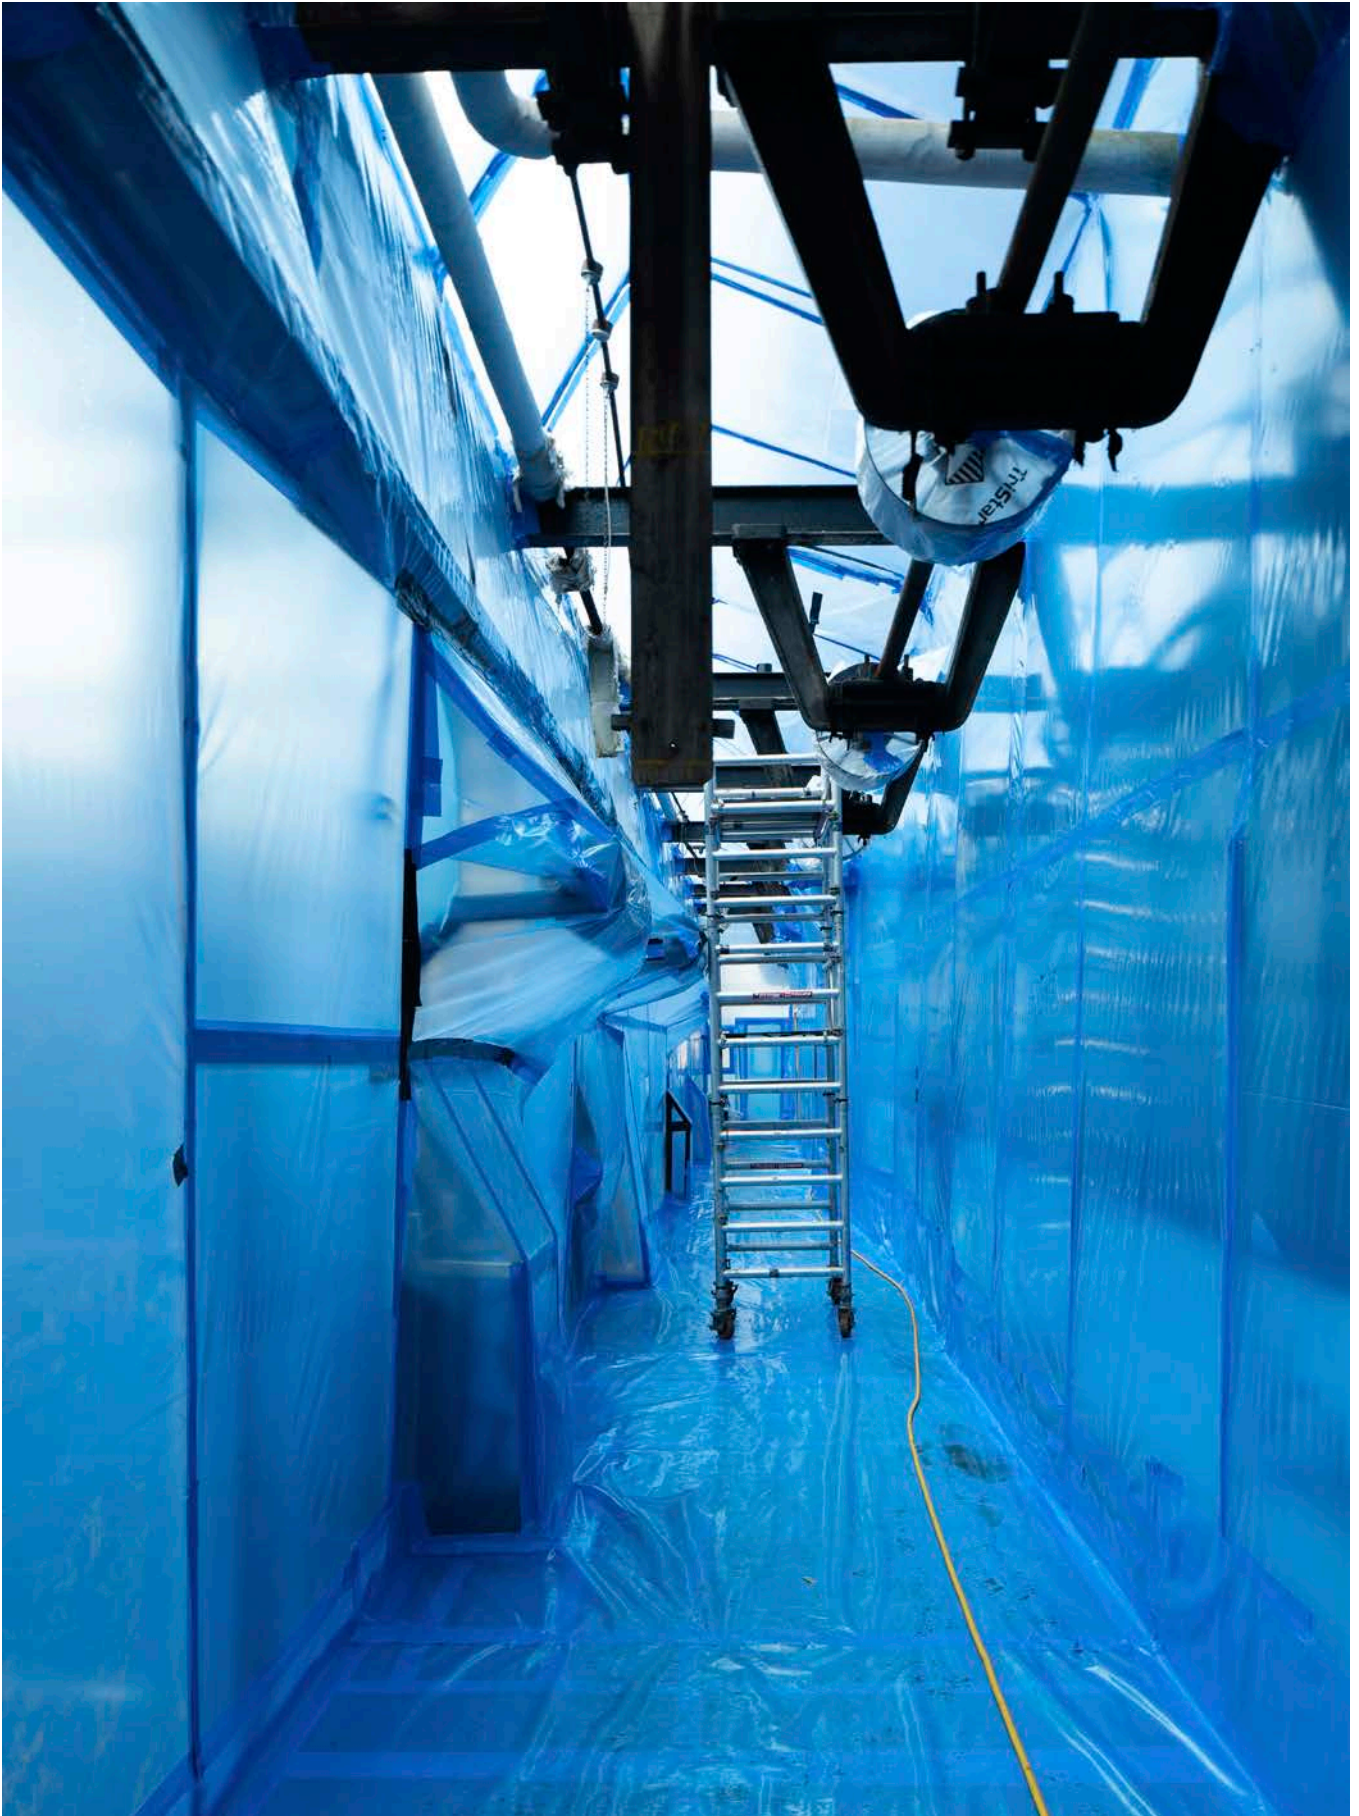
Generally, decontamination requires full enclosure of all work areas, utilising simply shaped structures that are easy to construct and clean. For Tone Works, the contractor had to adapt the shapes and locations of these enclosures to accommodate the bat access points, as identified by JH Ecology. The contractor created funnels to maintain access to below-ground channels for crevice-dwelling bats. They were carefully configured to protect the bats from disturbance from adjacent work areas.

Figure 16: Bespoke asbestos enclosure to accommodate historic fixtures and bat paths. © Claire Fear

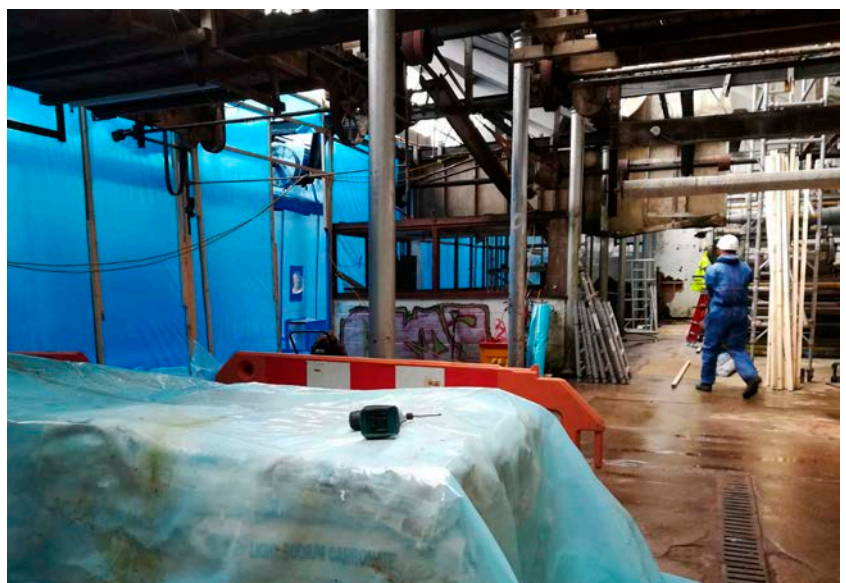
Figure 19: Asbestos decontamination works in progress, 2021. © Vanessa Ruhlig

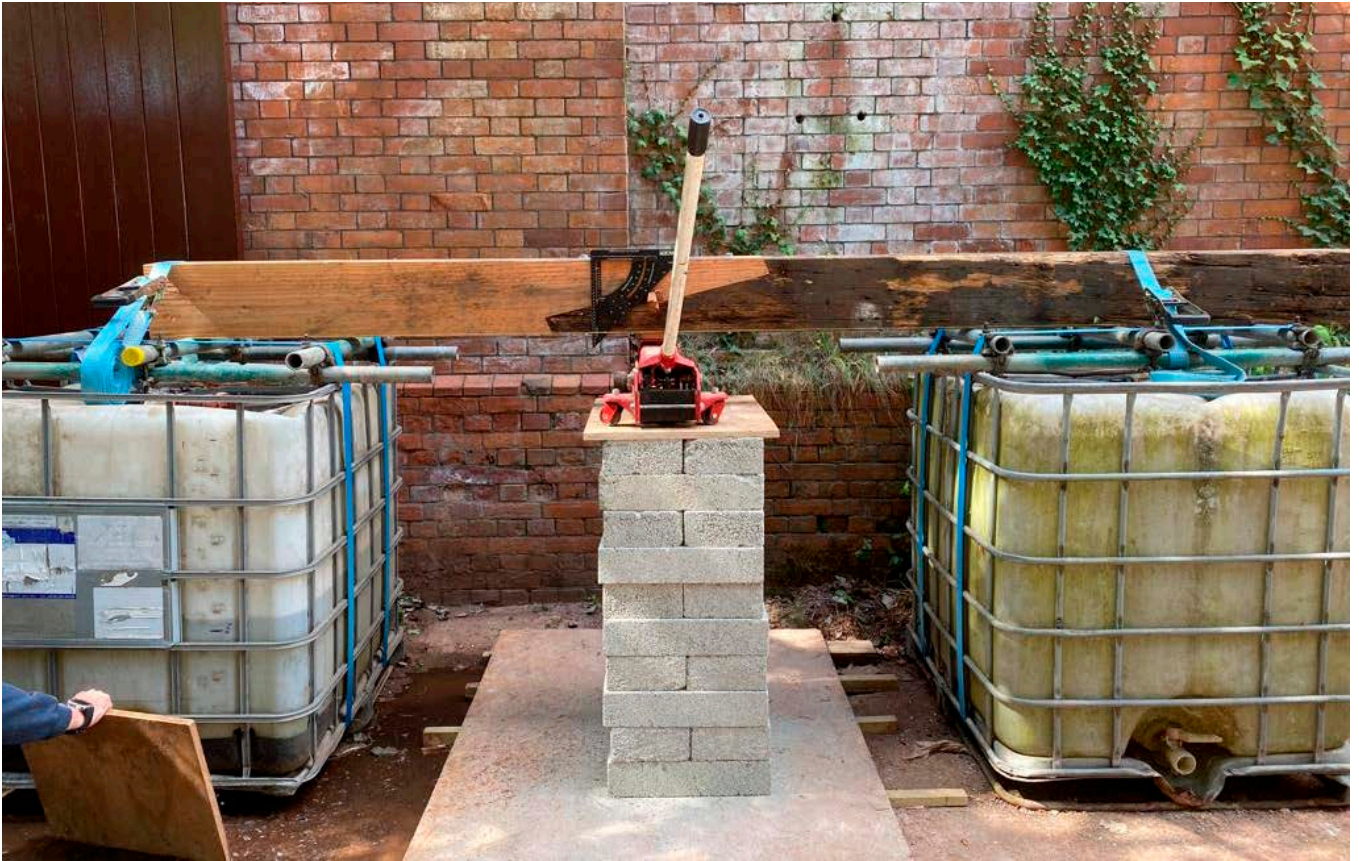
Figure 20: A scarf joint is load- tested on site to test actual strength. © Phil Shannon
