ENGLISH HERITAGE

HERITAGE AT
RISK
REGISTER
2012

YORKSHIRE AND
THE HUMBER

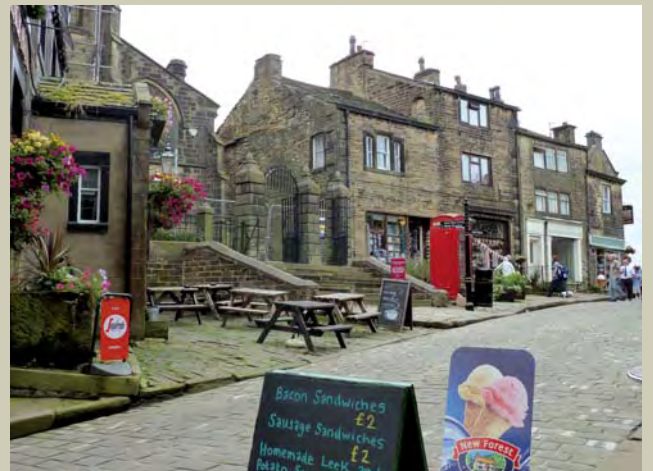
HAWORTH

Poor maintenance and cumulative changes are threatening Haworth's reputation as a high-quality tourist destination. In partnership with Bradford Council, local groups and business owners, English Heritage is working to restore the character of the village and create a more authentic atmosphere for visitors.
