Heritage at **Risk**

South East Register 2017

South East Summary 2017

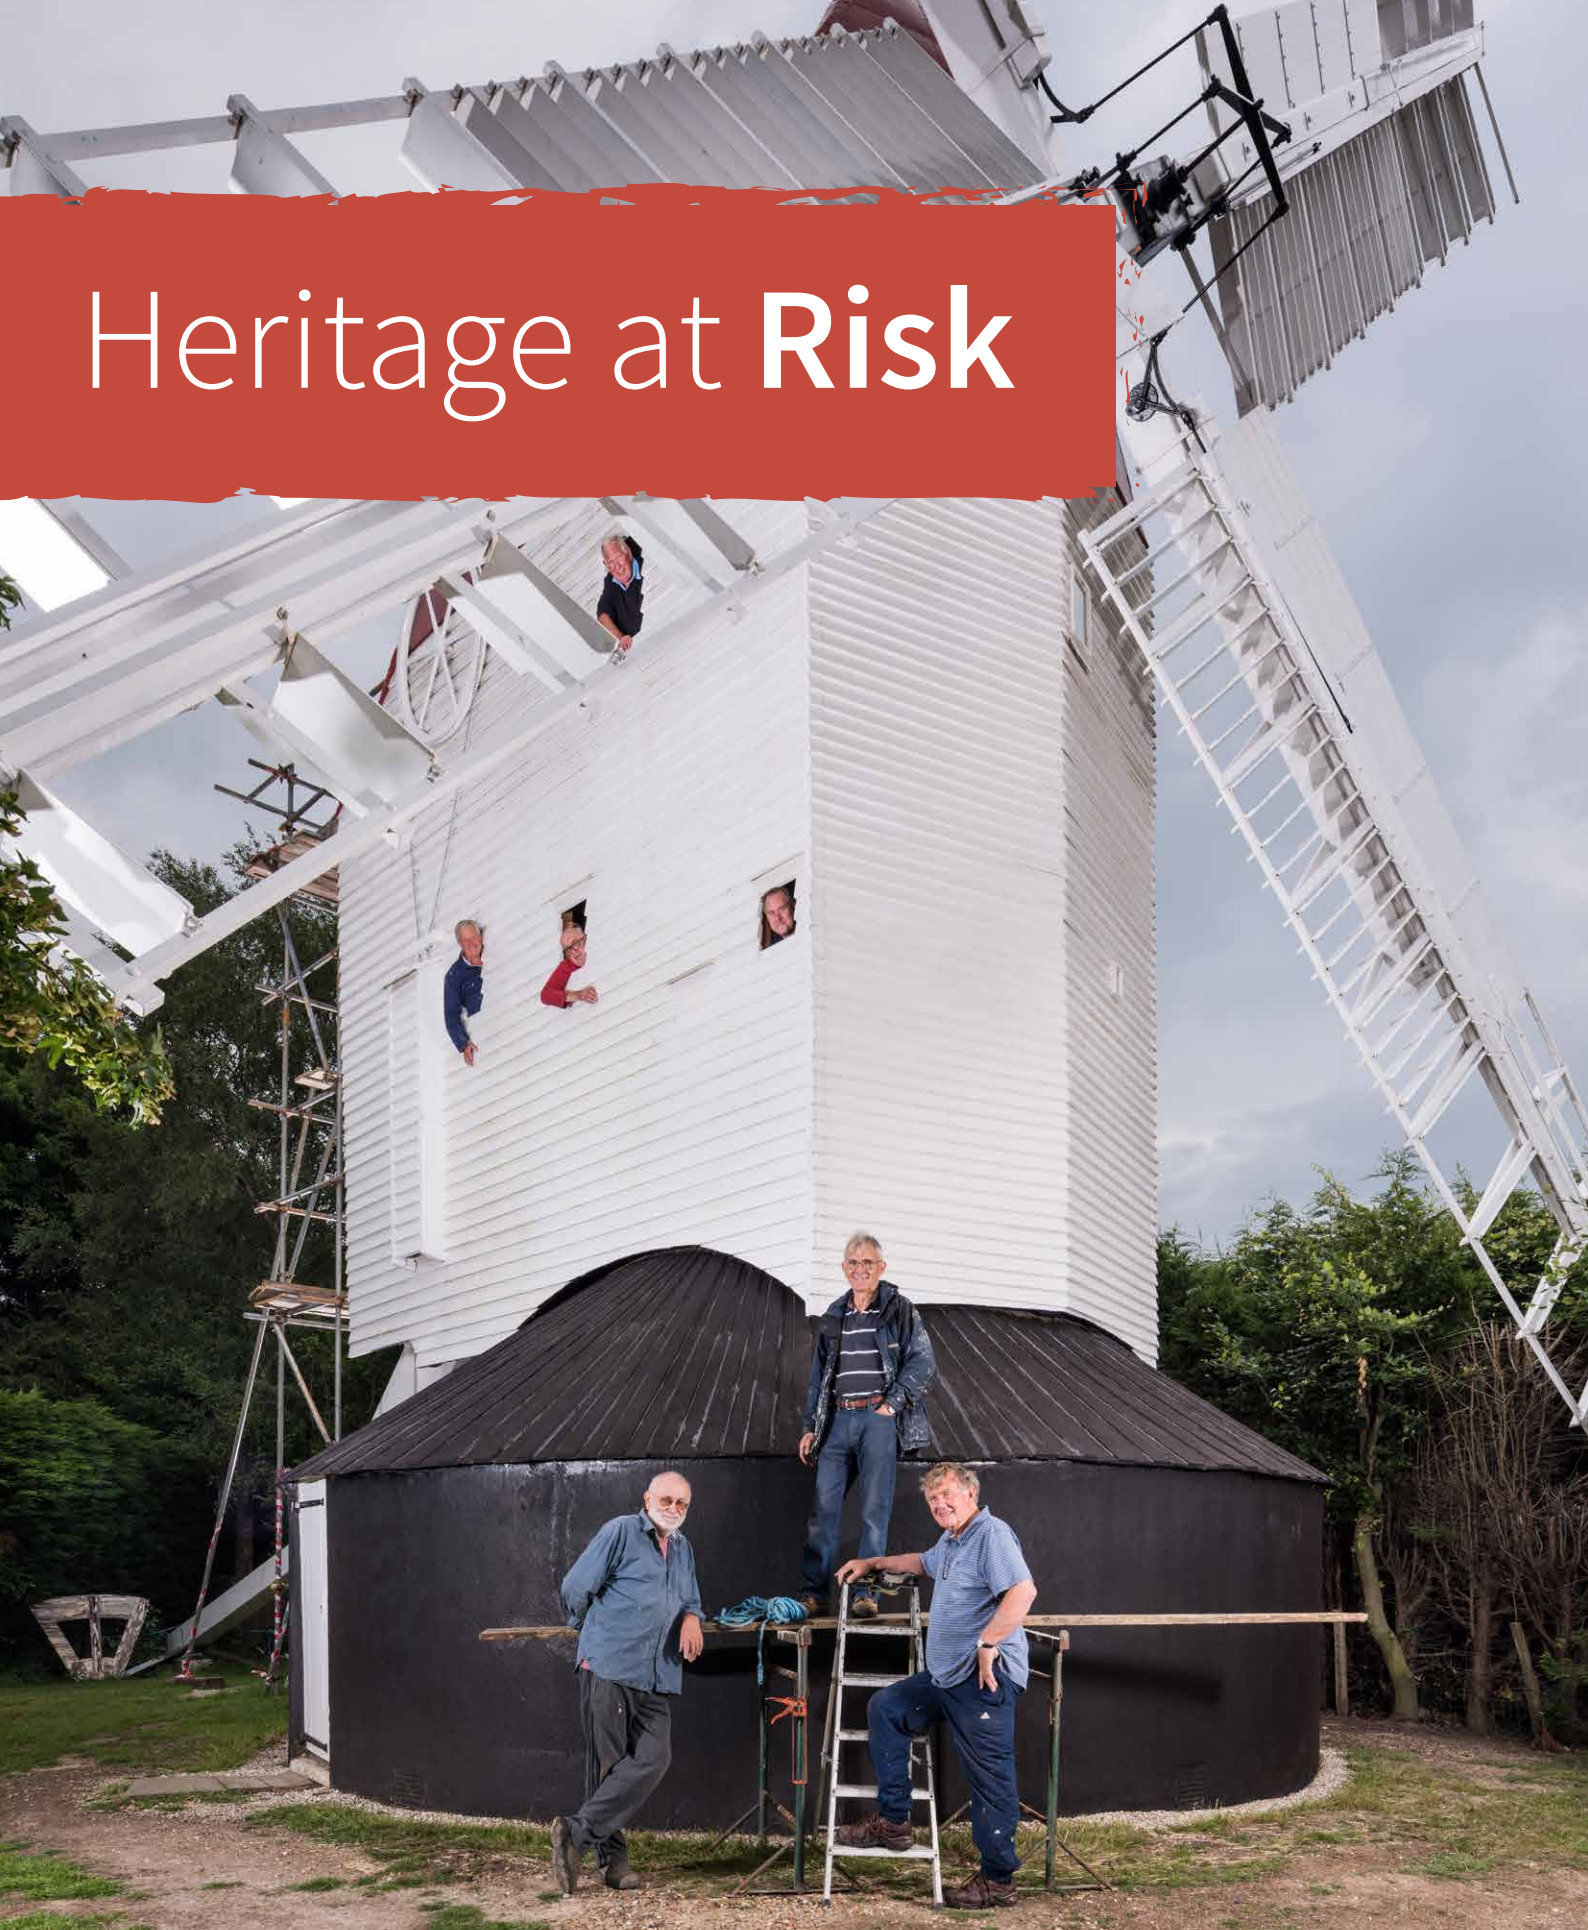
Cover image: Argos Hill Windmill is a post mill, clad with weather-boarding with a brick round house. Its fan and the shutters of its sweeps were missing and the building was suffering from lack of maintenance. A volunteer group called the Argos Hill Windmill Trust leased the windmill with a view to saving it, and launched a fundraising campaign for its restoration. Advice from Historic England, and successful funding bids to the Heritage Lottery Fund and Architectural Heritage Fund, have resulted in its repair and removal from our South East Heritage at Risk Register this year.

This year, we have spent more Historic England grant funding in the South East than ever before. Those who have followed our work in previous years will be pleased to see that repairs to the at risk scheduled small defensive structures at the former RAF Bicester (page 3) are progressing well with our assistance. Even where we have not been able to contribute financially, advice from our technical experts has had a positive impact, as at Argos Hill Windmill (cover) which is being removed from our Register this time.

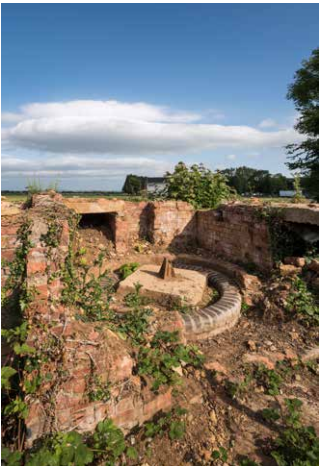
Former RAF Bicester **Launton, Oxfordshire**

The former RAF Bicester site appeared on our South East Heritage at Risk Register cover in 2015. The site, now Bicester Heritage, is the most complete example of a RAF bomber airfield from the interwar expansion period in the UK, and contains a great number of protected buildings including

bomb stores and defensive structures such as pillboxes, shelters and trenches.

Since 2015, Historic England has worked with the owners giving advice and grant aid to help them repair some of the small defensive structures that had fallen into disrepair across the site. This has enabled them to be seen by visitors to the site as a reminder of the vital role that the site once served in the defence of the nation.

Knowing the structure's purpose will make it easier to ensure that the repairs, which are due to take place during the next twelve months, will conserve and reveal all that is important about it and secure its contribution to the story of the site.

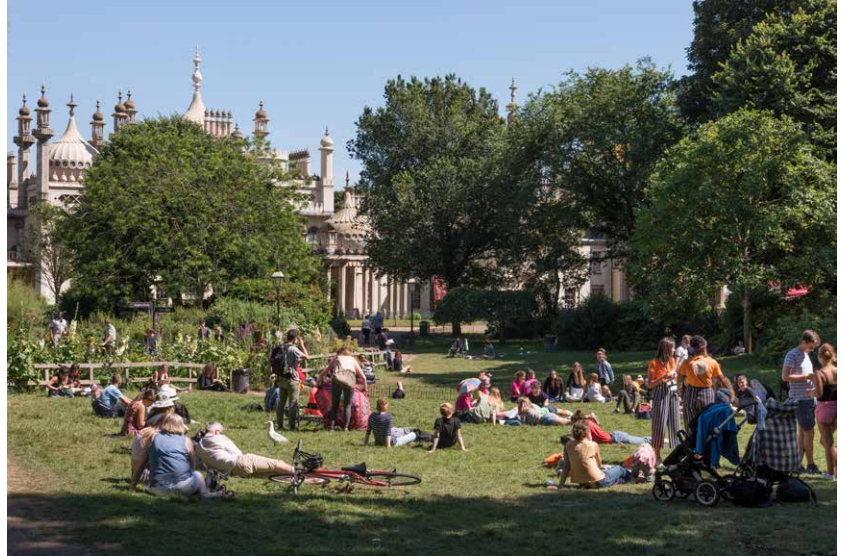
The Royal Pavilion Gardens Brighton

The Gardens which surround the iconic Royal Pavilion at Brighton were designed by John Nash, and are a picturesque layout of serpentine walks and drives, with sinuous flowery shrubberies and trees dotted casually over open lawns. The Gardens were subject to a landscape restoration in the late 1980s, but since then they have become a victim of their own success, and they have begun visibly to suffer from the high levels of visitor use and recreational development pressure. In addition, there has been an erosion of character caused by a disparate range of fencing, litter bins, signage and lighting units, all of which combine to weaken the sense of the Gardens' rich history for visitors.

By adding the Gardens to our South East Heritage at Risk Register this year we aim to focus attention on the need for some improvement to return them again to their former glory as a perfect foil for the magnificent Royal

Pavilion. We will be working with Brighton and Hove City Council to develop a Conservation Management Plan which will identify how to redress the balance and develop a strategy for keeping the Gardens in good condition for many years to come.
